Forgotten electrical accidents and the birth of shockproof X-ray systems

Gerrit J. Kemerink · Gerhard Kütterer ·
Andrew Wright · Frank Jones · Jeff Behary ·
Jan A. M. Hofman · Joachim E. Wildberger

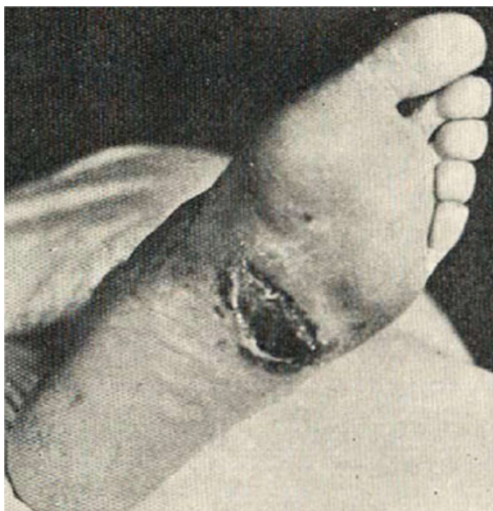
Fig. 1 Wound at area of contact with foot switch, 17 days after electrical accident [14]

Figure 1 shows the wound in the sole of the foot of a radiologist who came into contact with high-voltage while his foot was on an effectively earthed on/off switch. His boot was charred at the contact area. He was momentarily unconscious but recovered [14].

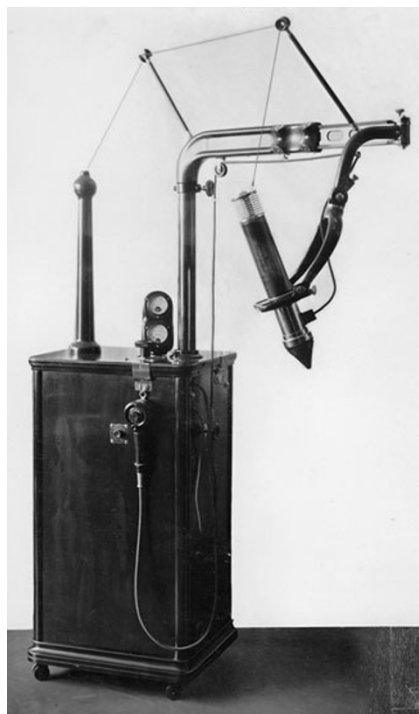
Fig. 10 Dental X-ray system from Ritter Dental with a Philips Metalix A tube. The cathode was grounded, but the radiator at the end of the tube had anode potential (system from around 1921–1924) [48]

shows the wiring of a mobile system, Fig. 10 for a dental system.

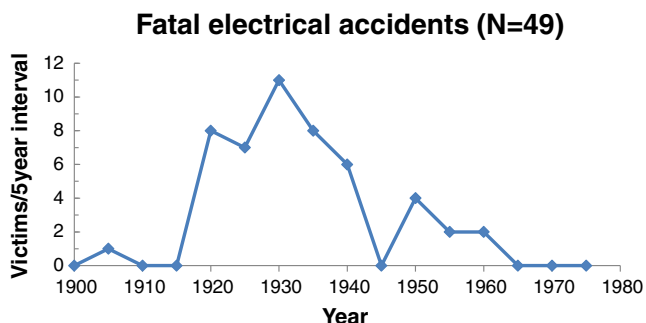
Fig. 14 Rate of fatal electrical accidents involving X-ray systems. Two cases, which occurred between 1919 and 1933, are not included

We were interested in the accident rate as a function of time because this might allow investigation into a correlation with instrumental developments. The fatal accidents are shown in Fig. 14 and the non-fatal in Fig. 15. Unfortunately, not all sources specified the date of the accident; thus, two fatal accidents are omitted from Fig. 14. In Figure 15 there are 11 omitted cases.
