Imaging of pancreas transplantation and its complications

Manuela França · Manuela Certo · Lasaete Martins · Pedro Varzim ·
Manuel Teixeira · António Castro Henriques · António Manuel Ribeiro ·
Filipe Caseiro Alves

Received: 25 June 2010 / Accepted: 10 September 2010 / Published online: 1 October 2010
© European Society of Radiology 2010

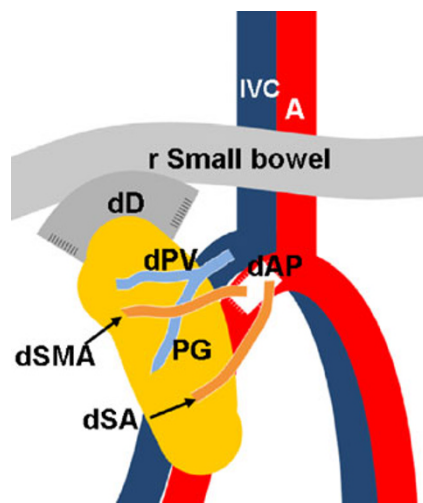
Fig. 1 Illustration of the pancreas transplantation technique performed at our institution, using duodeno-enterostomy for exocrine drainage and systemic endocrine drainage. The donor's aortic patch (*dAP*) with the origin of the superior mesenteric artery (*dSMA*) and the splenic artery (*dSA*) is anastomosed to the recipient's common iliac artery; the donor's portal vein (*dPV*) is anastomosed to the recipient's common iliac vein. *PG* pancreatic graft, *dD* donor's duodenum, *rSmall bowel* recipient small bowel, *IVC* inferior vena cava, *A* aorta

At our centre, transplantation of the whole pancreatic graft is performed with a duodenal segment, with systemic endocrine drainage via the grafted portal vein into the recipient's inferior vena cava or common iliac vein, and enteric exocrine drainage via the anastomosis of the donor's duodenal segment to the recipient's small bowel (Fig. 1). Pancreatic endocrine drainage may also be performed to the

recipient's portal venous system [3, 4] and/or the exocrine drainage may be derived to the bladder, but these surgical techniques have never been performed at our institution. Arterial supply to the pancreatic graft is performed through a donor's aortic patch, containing the splenic artery and the superior mesenteric artery (SMA), which is anastomosed to the recipient's common or external iliac artery. The pancreatic graft is placed intraperitoneally laterally in the pelvis (preferably on the right side), with the duodenal segment facing cephalad. The donor's duodenal segment is anastomosed side-to-side to the recipient's small bowel (duodeno-enterostomy). The recipient's native pancreas in the upper abdomen is left untouched. When simultaneous kidney-pancreas transplantation is performed, the donor's kidney is preferably placed in the contralateral side of the pelvis, most frequently at the left iliac fossa.

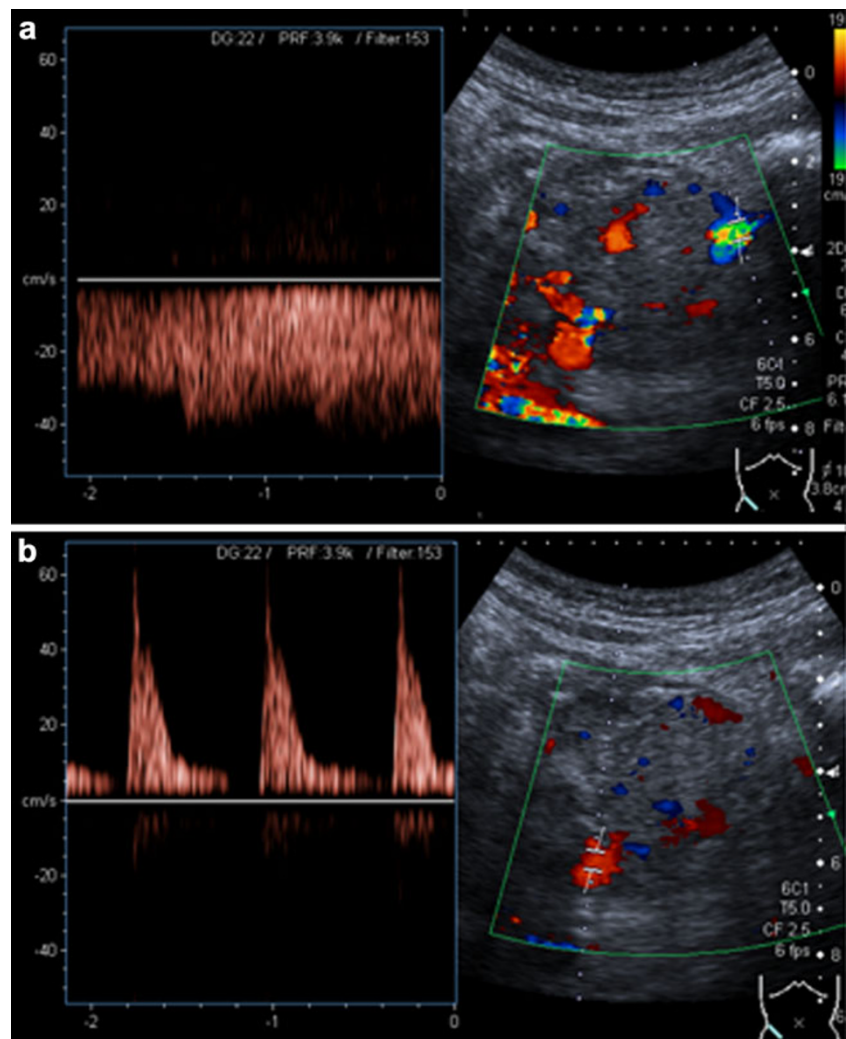
Fig. 2 Normal findings at colour and spectral Doppler ultrasound examination of pancreatic graft veins (**a**) and arteries (**b**) displaying good organ perfusion and clear arterial spectra with normal resistive index

Imaging evaluation of the pancreas transplant grafts is commonly performed by a multi-technique approach. *Ultrasound* is usually the first technique to be used to search for early complications [4], as it is routinely performed in the postoperative period (in the first 24 h). In grey-scale B-mode, the normal pancreatic graft presents homogeneous echotexture, lower than the native pancreas and the surrounding mesenteric or epiploic fatty tissue. Doppler imaging provides vascular assessment (Fig. 2), with allograft vein velocities ranging between 10 and

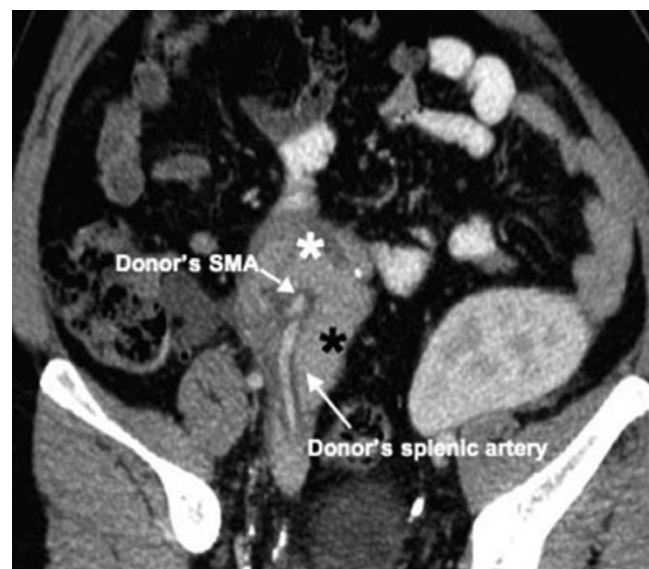
Fig. 3 MPR coronal oblique contrast-enhanced MDCT images showing a normal pancreatic graft arterial supply after SPK transplantation. The donor's superior mesenteric artery (SMA) supplies the pancreatic graft head (*white asterisk*), and the donor's splenic artery irrigates the graft body and tail (*black asterisk*)

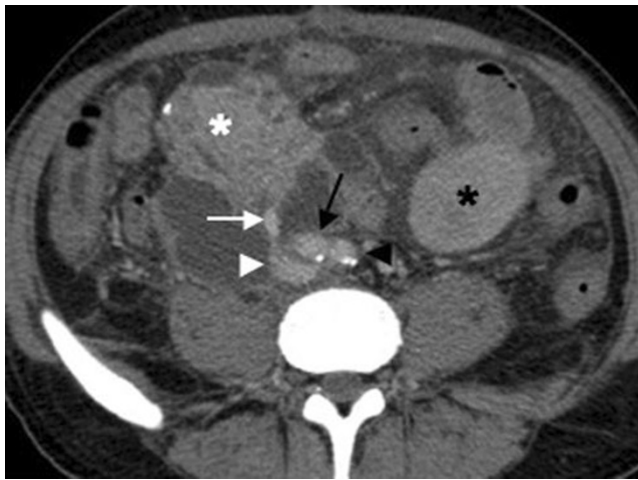
Fig. 4 Axial contrast-enhanced MDCT after SPK transplantation. End-to-side anastomosis is used to connect the donor's portal vein (white arrow) to the recipient's right common iliac vein (white arrowhead). Homogeneous fluid collections adjacent to the pancreatic graft are observed. Black arrow right common iliac artery; black arrowhead left common iliac artery; white asterisk pancreatic graft; black asterisk renal graft

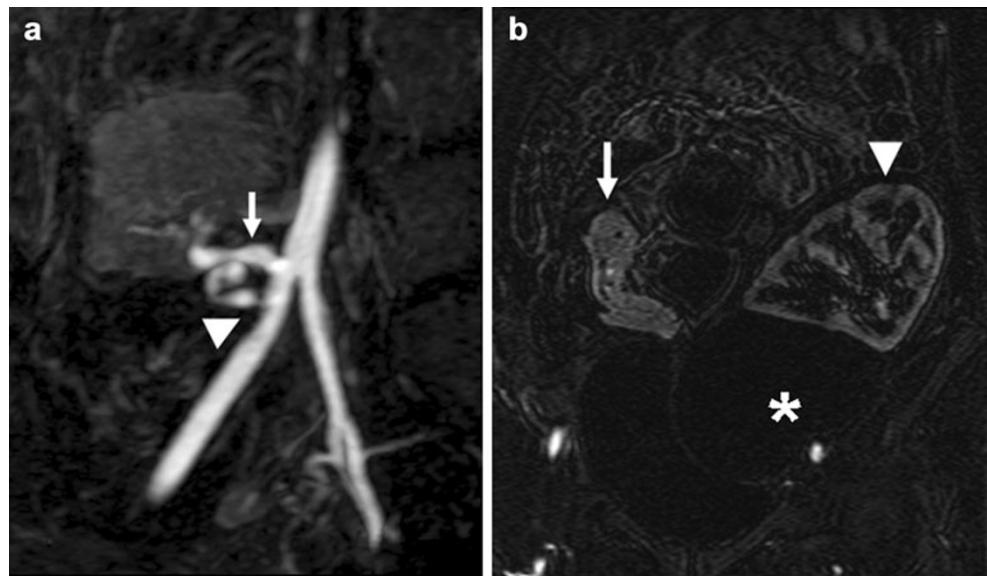
Fig. 5 A 32-year-old female patient after SPK transplantation. **a** Coronal MIP image in the arterial phase of an MRA study demonstrates the arterial vessel anatomy of the pancreatic graft. Note that the donor's SMA (arrow) presents normal calibre and the donor's splenic artery (arrowhead) shows a stenosis with mild post-stenotic dilation. **b** MR angiography in the arterial phase shows normal enhancement of the pancreas (arrow) and kidney (arrowhead) transplants. At the lower pole of the kidney graft a large lymphoceles is seen (asterisk)

Magnetic resonance imaging (MRI) has the advantage of allowing exploitation of the native signal intensity of the graft besides the vascular information provided by Gd-enhanced dynamic study (Fig. 5). Also, magnetic resonance cholangiopancreatography (MRCP) helps to depict ductal abnormalities [8]. At our institution, MRI is rarely used for examination of pancreatic graft-related complications because of its lower spatial resolution, creating difficulties in the assessment of the enteric anastomosis, and, also, because of technical constraints involved in imaging acutely ill and intensively monitored patients. Normal pancreas should be isointense to the renal graft parenchyma on T1-weighted images, with an intermediate signal on T2-weighted images and homogeneous enhancement after intravenous contrast medium administration [5, 9].

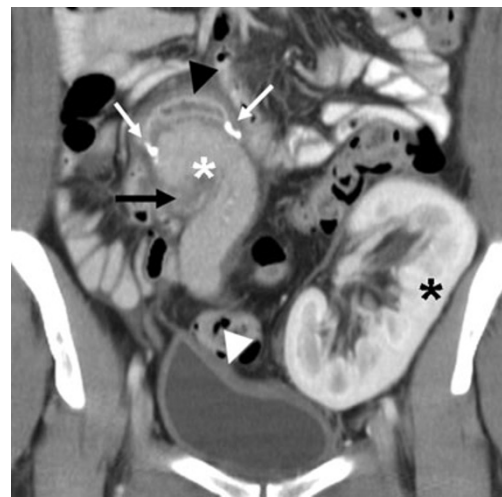
Fig. 6 Coronal reformatted MDCT image shows homogeneous enhancement of the pancreatic (white asterisk) and renal grafts (black asterisk) after SPK transplantation. The pancreas is placed laterally in the pelvis, on the right side, with the attached donor's duodenal segment facing cephalad (black arrowhead), which anastomoses to the recipient's jejunum. Surgical staples are present at the extremities of the duodenal segment (white arrows). Note the oedematous swelling of the donor's remaining mesenteric fat (black arrow) surrounding the pancreatic graft vessels. These findings are to be expected in the early postoperative period

In the immediate postoperative period, one should expect to find small peri-graft fluid collections, donor's duodenal wall thickening, mild pancreatic duct dilation, slight stranding of peri-pancreatic fat or oedematous swelling of the donor's remaining mesenteric fat, surrounding the mesenteric artery (Fig. 6) [5]. These imaging findings are usually self-limited, normally seen to be resolving spontaneously on follow-up examinations. Post-transplantation complications of the allograft may be classified as

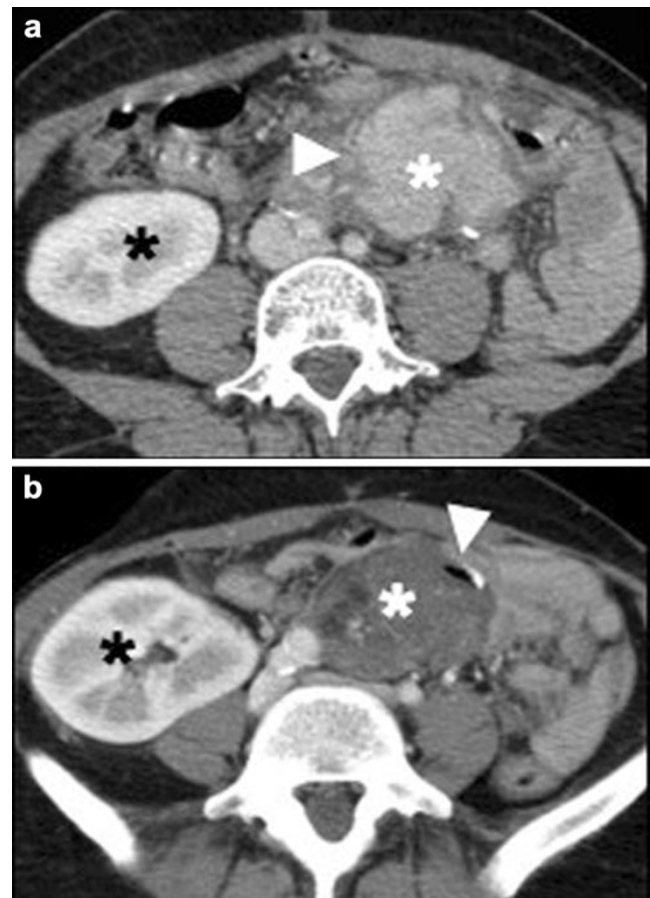
Fig. 8 A 40-year-old female patient after SPK transplantation. Axial contrast-enhanced MDCT (**a**) shows an enlarged pancreatic graft (white asterisk), with homogeneous parenchymal enhancement and peri-pancreatic fat stranding (arrowhead). The patient presented with interstitial oedematous pancreatitis. Two months later, axial contrast-enhanced MDCT (**b**) shows absent parenchymal enhancement of the pancreatic graft (white asterisk) and intra-pancreatic gas bubbles (white arrowhead). These findings were consistent with necrotising pancreatitis and graft pancreatectomy was performed. Black asterisk renal graft

exquisitely sensitive to diagnosing and determining the extent of parenchymal necrosis due to lack of enhancement and possible gas formation (Fig. 8) [8].

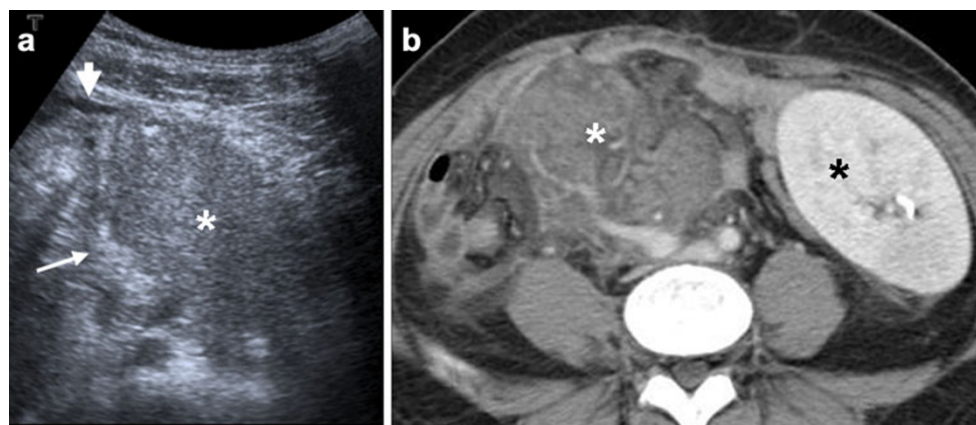
Fig. 7 A 36-year-old woman after SPK transplantation presenting graft pancreatitis. **a** Ultrasound shows enlarged pancreatic graft (asterisk) with adjacent hyperechoic fatty tissue (thin arrow) and a small amount of free intraperitoneal fluid (large arrow). **b** Axial

contrast-enhanced helical CT shows an enlarged pancreatic graft with heterogeneous contrast enhancement (white asterisk), peri-pancreatic fat stranding and free peritoneal fluid. Normal renal graft is located on the left (black asterisk)

occurring in about 10% of allografts [5]. Imaging findings are non-specific consisting of normal or enlarged pancreatic allograft, showing heterogeneous contrast enhancement, adjacent fat stranding and fluid collections (Fig. 7). Necrotising pancreatitis may occur in about 2–4% of the allografts [5] and is the most severe form of acute pancreatitis. Necrosis can result either from pancreatitis itself or from direct vascular occlusion. On ultrasound, necrosis manifests as hypoechoic areas within the graft parenchyma, sometimes with hyperechoic foci suggesting gas formation. Doppler interrogation assists in confirming absent arterial or venous flow within the affected segments of the pancreatic graft [9]. Contrast-enhanced CT or MRI is

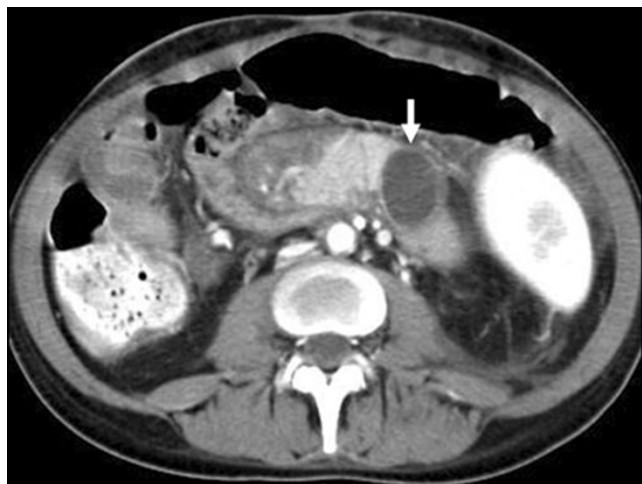
Fig. 9 A 36-year-old male patient after SPK transplantation with pancreatitis and pseudocyst formation. Axial contrast-enhanced CT shows heterogeneous enhancement of the pancreatic graft and a thin-walled pseudocyst (arrow)

Pseudocysts typically develop in the severe form of pancreatitis, usually being located within (Fig. 9) or adjacent to the graft (Fig. 10) [5, 8]. Imaging reveals thin-walled fluid collections. Wall thickening showing contrast

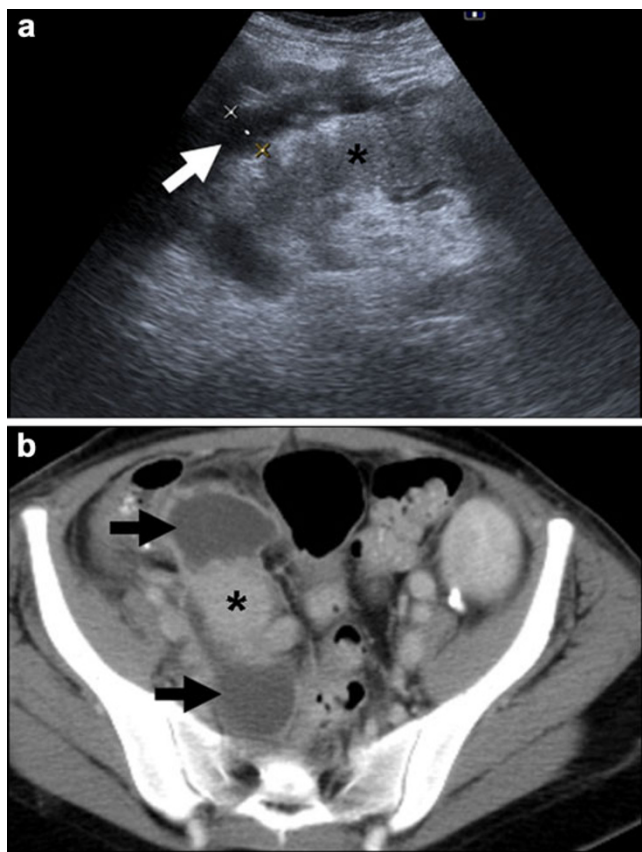
Fig. 10 A 30-year-old woman 5 weeks after SPK transplantation with an infected peri-pancreatic pseudocyst. Sagittal ultrasound of the right lower quadrant (a) demonstrates a peri-pancreatic fluid collection (white arrow). Axial contrast-enhanced MDCT (b) shows homogeneous contrast enhancement of the pancreatic graft (asterisk) surrounded by a thin, contrast-enhanced wall fluid collection (black arrows). Image-guided percutaneous drainage confirmed superimposed infection of the pseudocyst

Abscesses may result from infection of peri-pancreatic fluid collections, pseudocysts (Fig. 10), leakage of the enteric anastomosis (Fig. 13), or abdominal wall surgical wound infection [5]. They usually present as complex fluid collections, with a thick wall and possible intralesional gas. Either ultrasound or CT can be used to guide the percutaneous drainage of these collections.

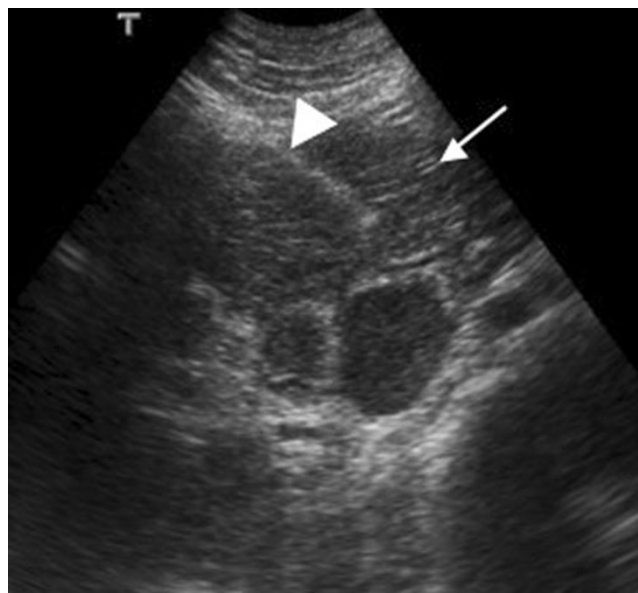
Fig. 11 A 29-year-old patient with rejection of the pancreatic graft after SPK transplantation. Ultrasound-guided biopsy of the pancreatic graft (arrowhead needle biopsy). Pancreatic graft (arrow) shows normal size but with heterogeneous texture of the parenchyma

heterogeneous parenchymal enhancement. As imaging and laboratory values are non-specific, graft biopsy is the only reliable test to diagnose graft rejection [10]. Graft biopsy can be performed under ultrasound or CT guidance (Fig. 11), and a low rate of complications has been previously reported [11].

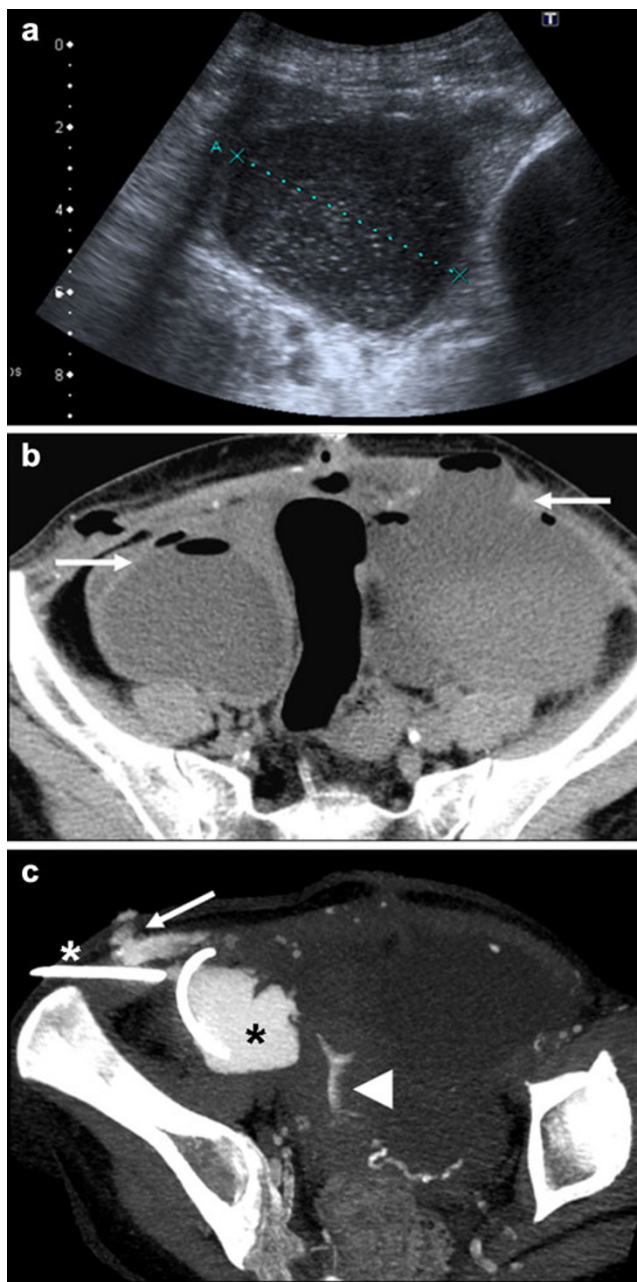
Fig. 12 A 30-year-old woman after SPK transplantation. **a** Abdominal ultrasound shows peri-pancreatic graft collections with a thick wall and echogenic content; **b** axial MDCT reveals multiple abscesses at the abdomen and pelvis, with extension to the abdominal wall. Ultrasound-percutaneous drainage was performed and chemical analysis of the fluid showed high amylase content, compatible with a pancreatic fistula. **c** A 3D-MPR MIP reconstructed from follow-up MDCT performed 3 days later, with introduction of iodinated contrast agent through the percutaneous drain (*white asterisk*), demonstrates the extension of intra-abdominal collection (*black asterisk*) and the fistulous tract to the abdominal wall (*arrow*). Contrast agent was also detected inside the uterine cavity (*arrowhead*) suggesting a fistula. Despite this complication, the pancreatic and renal grafts functioned normally

A pancreatic fistula usually appears as peri-pancreatic graft collection possessing high amylase levels when a puncture is performed. On MRCP, communication with the main duct may be identified. Although fistulas tend to resolve with conservative treatment, infection (abscess) or fistulous tract to the skin, peritoneal cavity, gut or uterine cavity may also develop; thus, follow-up imaging should be proposed (Fig. 12) [8].

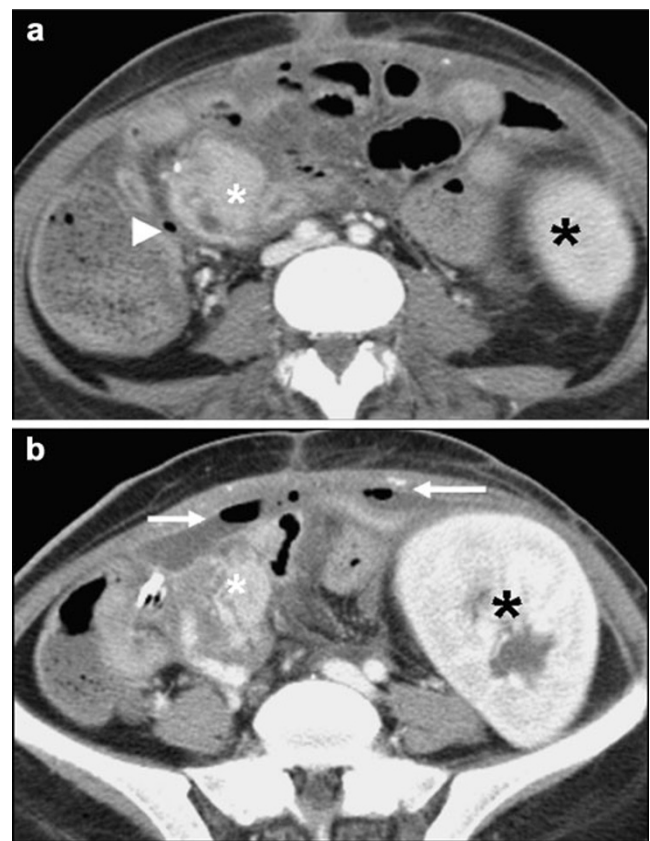
Fig. 13a, b A 30-year-old woman after SPK transplantation. Axial MDCT performed six weeks after transplantation shows intra-abdominal fluid collections with contrast-enhancing wall, with air-fluid levels (*arrows*), consistent with abscesses. Ascites and gas bubbles (*arrowhead*) are noted near the duodeno-enterostomy. The pancreatic (*white asterisk*) and renal grafts (*black asterisk*) enhance homogeneously. Duodenal dehiscence was suggested. The patient underwent surgery, which revealed a fistula at the donor's duodenal cuff

These are mainly represented by anastomotic leakage at the duodeno-enterostomy site and small bowel obstruction. CT is especially useful for evaluating these complications, directly demonstrating intra-abdominal abscesses, peritoneal inflammation (Figs. 13 and 14), or the enteric leakage observed as

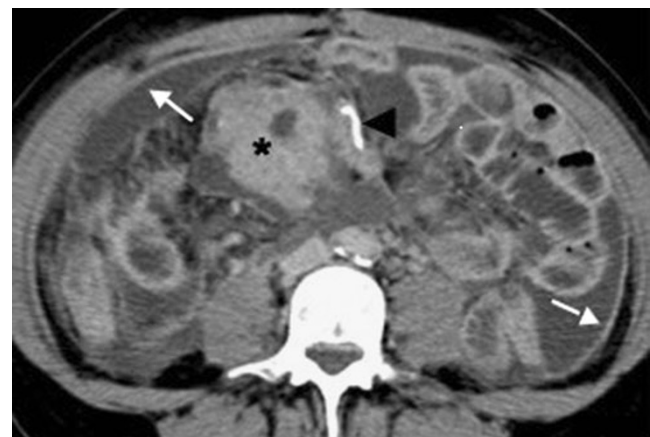
Fig. 14 A 37-year-old woman with peritonitis 5 weeks after SPK transplantation. Contrast-enhanced MDCT shows fluid collections surrounded by enhanced peritoneum (*arrows*). *Asterisk* pancreatic graft, *arrowhead* surgical staples at the graft's duodenal segment

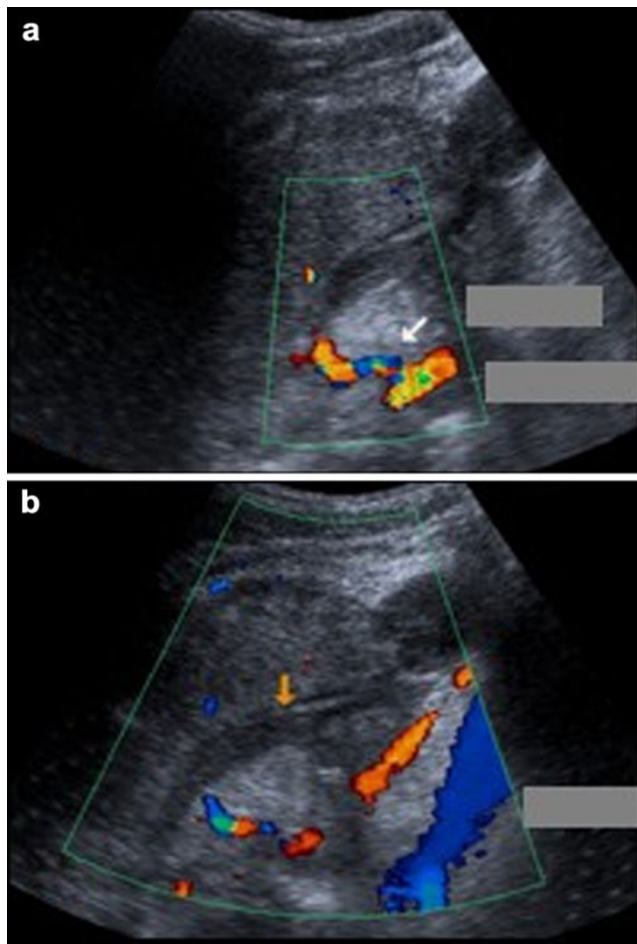
Fig. 15a, b A 37-year-old man after SPK transplantation, with persistent amylase elevation. Abdominal ultrasound-Doppler performed 2 weeks after transplantation shows the iliac arteries and the graft's arterial vessels (**a** arrow) permeable but with aliasing and high resistive index (RI). The iliac vein showed normal flow. However, no flow was detected at the graft's portal vein, suggesting thrombosis (**b** arrow). At surgery, thrombosis was confirmed and pancreatectomy was performed

Venous or arterial graft thrombosis is a serious complication, being the second most common cause of transplant dysfunction after graft rejection [14]. Generally, it results in massive graft necrosis and requires pancreatectomy [8]. Doppler ultrasound depicts parenchymal heterogeneity with absent pulsatile or continuous flow of the pancreatic graft vessels (Fig. 15). In cases of venous thrombosis, pan-diastolic reversal of the arterial flow and a resistive index greater than 1.0 can be seen [9]. Intravenous contrast agent administration is especially useful for demonstrating intraluminal filling defects in the graft vessels and the lack of the parenchyma's enhancement (Fig. 16) [8, 15–17]. Emphysematous changes can occur with further progression to parenchymal necrosis. When superimposed infection is suspected, image-guided biopsy should be performed [8].

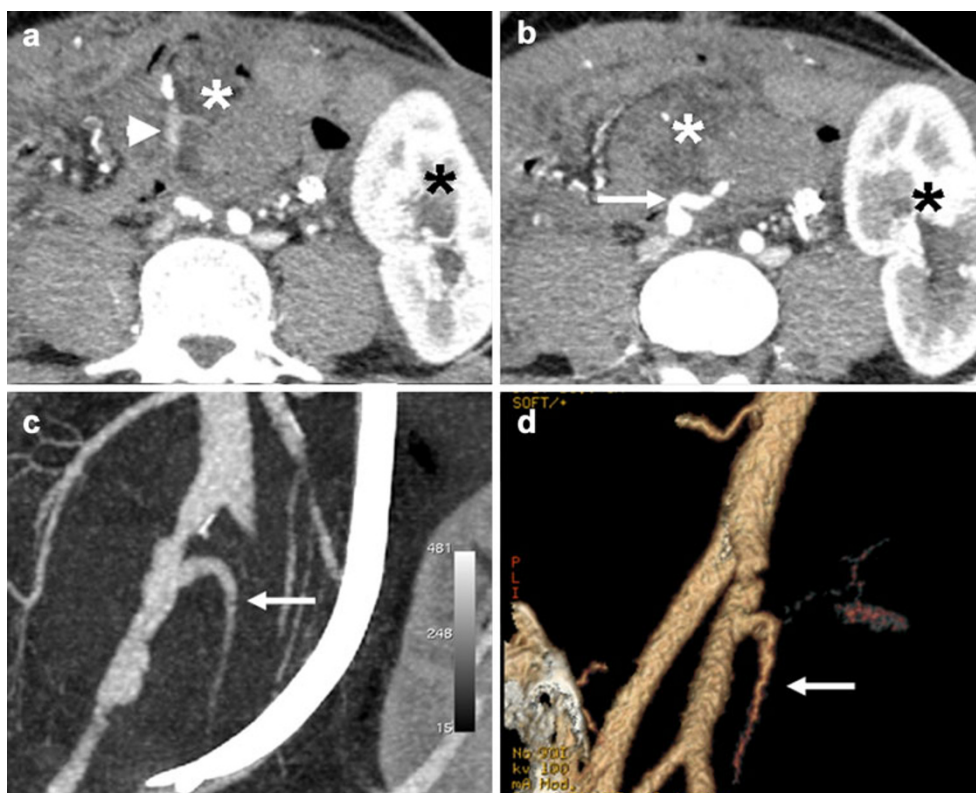
Fig. 16a–d A 37-year-old patient, the same patient as in Fig. 17, a day after a second pancreatic transplant. Axial MDCT (**a, b**) shows heterogeneous enhancement of the pancreatic head of the graft with normal, contrast-enhancing iliac arteries and the graft's splenic artery (*arrow*). Poor enhancement of the graft's SMA is noted (*arrowhead*), together with non-enhancing arterial segments, suggesting occlusion. There is homogeneous enhancement of the renal graft (*black asterisk*). Coronal reformatted MIP image (**c**) and VR reconstruction (**d**) illustrate the graft's splenic artery (*arrow*) but not the graft's SMA. The patient underwent pancreatectomy and the arterial occlusion was confirmed

Early arterial occlusion of the pancreatic graft is usually due to technical surgical difficulties involved in performing the ligation of small pancreatic arterial vessels during organ harvesting. Late occlusion is generally related to the end point of graft rejection because of progression of the alloimmune response [8].

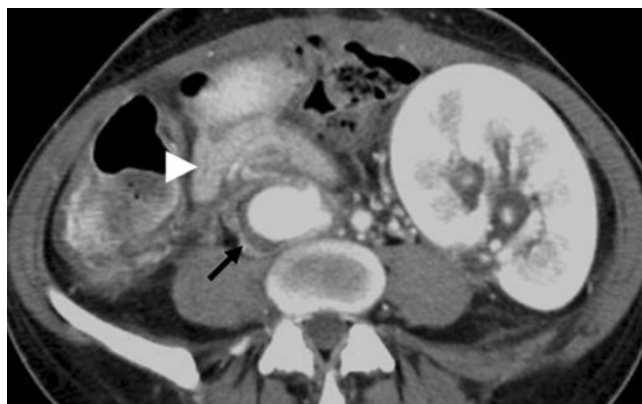
Fig. 17 A 36-year-old female patient after SPK transplantation. Contrast-enhanced CT performed 4 weeks after graft pancreatitis shows homogeneous pancreatic graft enhancement (*arrowhead*) and a partially thrombosed pseudoaneurysm of the right common iliac artery (*arrow*)

Arterial or venous pseudoaneurysms may develop after pseudocyst infection or after biopsy [8, 9, 18]. On Doppler ultrasound, they present as blood-filled lesions. Direct communication with the feeding vessel may also be identified and pulsed-wave Doppler ultrasound may show “to-and-fro” waveform at the pseudoaneurysm neck. Contrast-enhanced CT or MRI is better for demonstrating the focal loss of vessel wall integrity (Fig. 17).

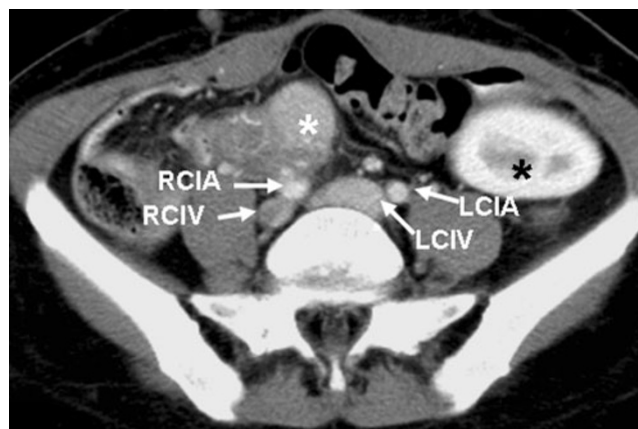
Fig. 18 A 44-year-old woman after SPK transplantation. Contrast-enhanced MDCT shows non-enhancement of the right common iliac vein compared with left side. This results from the longer transit time and the reduced blood flow of the right-sided pancreatic graft (*white asterisk*) compared with the left-sided renal graft (*black asterisk*)

When a simultaneous pancreas-kidney transplant is performed, with bilateral revascularisation to the respective iliac vessels, delayed opacification of the iliac vein ipsilateral to the pancreatic graft may be observed, compared with the contralateral iliac vein draining the kidney transplant (Fig. 18) [19]. This finding should not be interpreted as a real thrombosis of the iliac vein.
