Imaging of breast implants—a pictorial review

Abstract The number of women with breast implants is increasing. Radiologists must be familiar with the normal and abnormal findings of common implants. Implant rupture is a well-known complication after surgery and is the main cause of implant removal. Although mammography and ultrasonography are the standard first steps in the diagnostic workup, magnetic resonance imaging (MRI) is the most useful imaging modality for the characterisation of breast implants because of its high spatial resolution and contrast between implants and soft tissues and absence of ionising radiation. MRI has the highest sensitivity and specificity for implant rupture, thanks to its sequences that can suppress or emphasise the signal from silicone. Regardless of the technique used, the overall aim of imaging breast implants is to provide essential information about tissue and prosthesis integrity, detect implant abnormalities and detect breast diseases unrelated to implants, such as breast cancer.

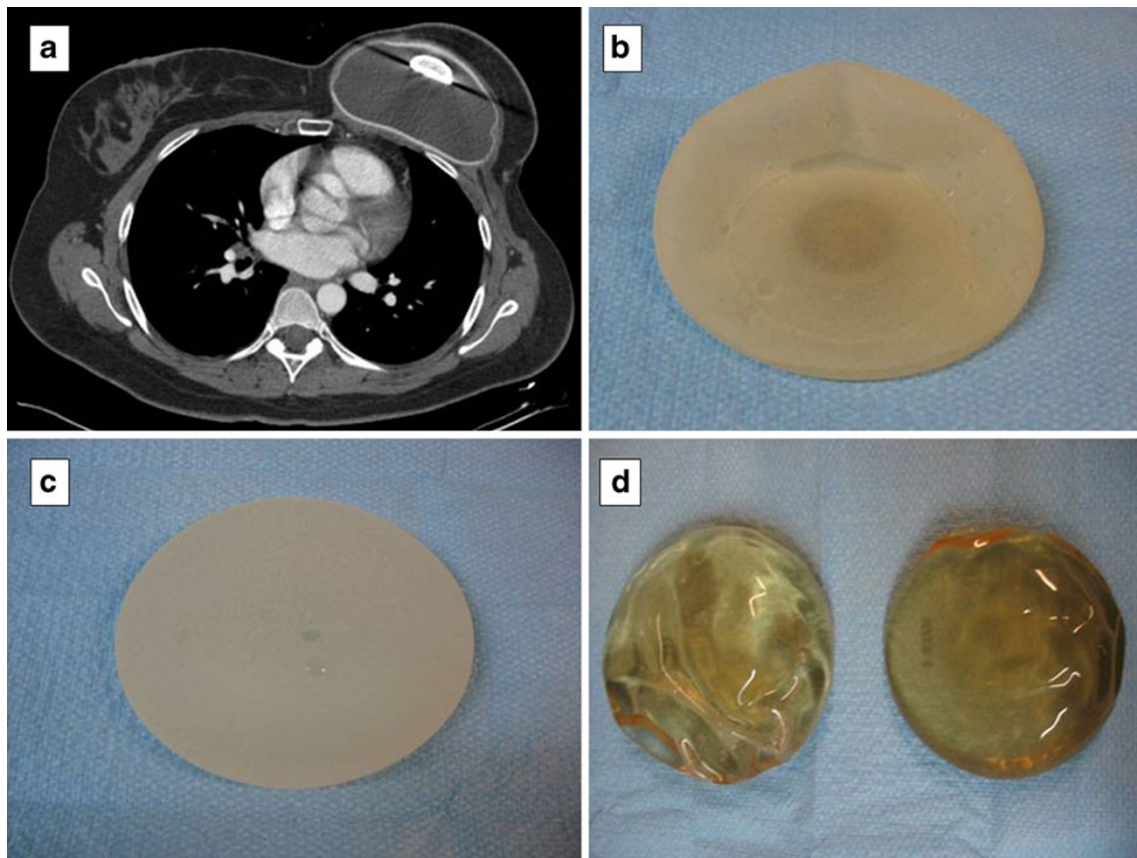
Fig. 1 Different implant types. **a** and **b** Breast tissue expander with metallic component visualised by computed tomography scan. Silicone gel implants with textured surface (**c**) and with smooth surface (**d**)

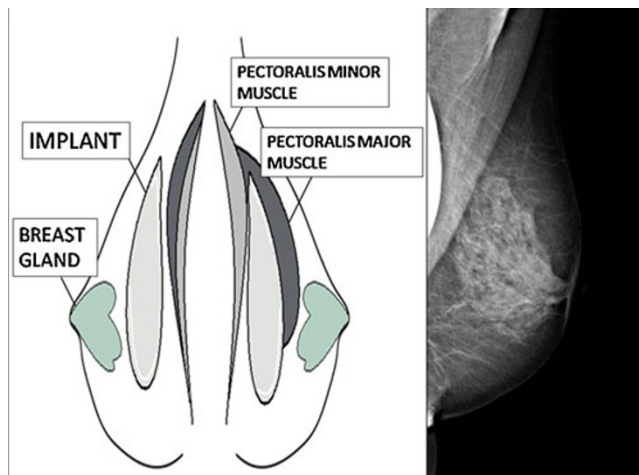
Fig. 2 Localisation of breast implants. (Left) Submammary implant located in front of the pectoralis major muscle and (right) submuscular implant located behind the pectoralis major muscle, visualised by mammography

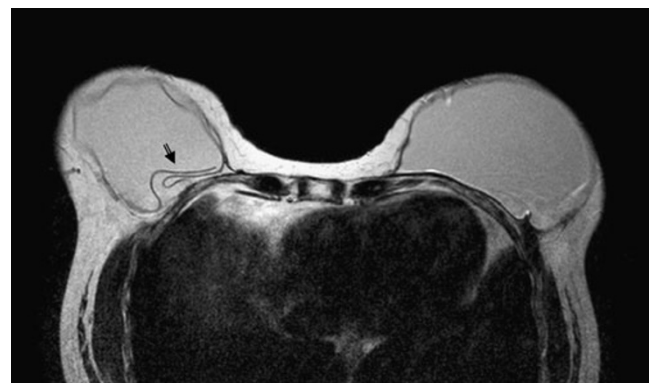
Fig. 3 Magnetic resonance imaging scan of a woman with bilateral breast silicone implants. Right implant with extracapsular rupture exhibiting the typical "linguine sign" at the posterior margin of the implant. Intact left silicone implant

Magnetic resonance imaging (MRI) is the most accurate technique in the evaluation of implant integrity. Its sensitivity for rupture is between 80% and 90%, and its specificity is between 90% and 97% [3, 5–16] (Fig. 3).

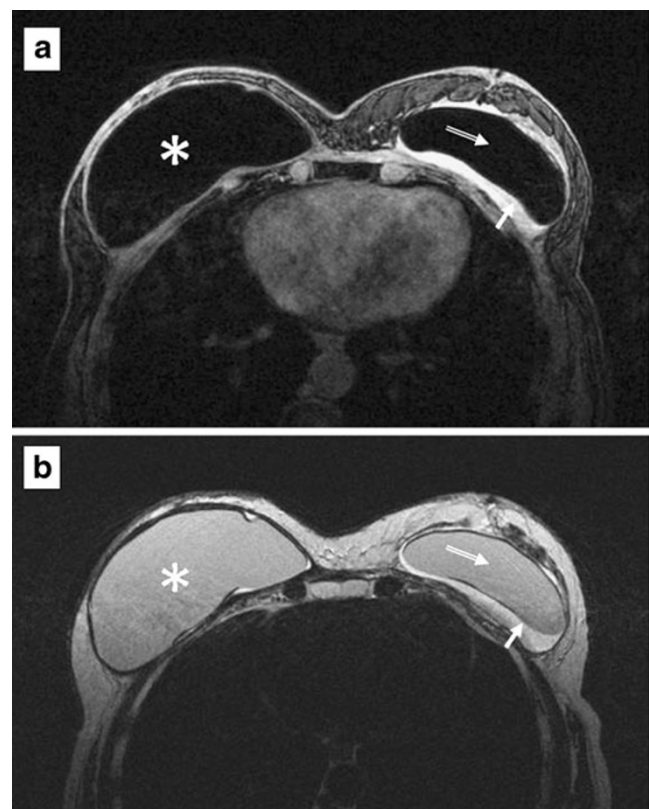
Fig. 5 MRI of a 61-year-old woman with bilateral implants: a single-lumen implant (right breast) and a double-lumen implant (left breast). (a) Axial silicone-suppression and (b) axial T2-weighted turbo spin echo sequences. The right implant has homogeneous signal intensity, representing a single lumen with silicone gel (*). The left implant has an inner lumen (open arrow) of low-signal-intensity or high-signal-intensity silicone surrounded by a smaller outer lumen (solid arrow) that contains saline

Breast reconstruction may involve the insertion of various types of implant or the modelling of autologous myocutaneous flaps. According to the literature, breast implants can be categorised into five implant generations reflecting product development over time. The recent generations of silicone gel implants have a cohesive viscous silicone gel. As a result of this feature, these implants will rarely have a totally collapsed implant shell, differing from the older generations. Moreover, most of them have gel leakage and silicone migration. The third and fourth implant generations offered models of breast implants with textured or uniformly smooth surfaces (Fig. 1), and it seems that capsular contracture rarely occurs in women with recent generations of breast implants. All implants in this article are silicone breast implants including single-lumen implants (the majority) and less commonly double-lumen implants (Fig. 5).

Figure 4 shows the MRI sequences used at our institution for breast implant study. The use of contrast agents in MRI studies for assessment of breast implant integrity is not recommended. However, when the priority is the detection of recurrence or residual tumors, contrast-enhanced MRI of the breast is useful for characterising parenchymal lesions [11, 13]. High-field-strength magnets of at least 1.5 T are preferred when imaging patients with silicone breast implants because of the ability to use magnetic resonance sequences that can more readily suppress or emphasise the signal from water, fat or silicone. Turbo-spin-echo T2-weighted images, short-time inversion recovery silicone excited (silicone hyperintense, water suppressed), and silicone-saturated (water hyperintense, silicone suppressed) are the most common and most important sequences in silicone breast implant assessment. A single-lumen silicone implant has an outer shell containing homogeneous high-signal-intensity viscous silicone on T2-weighted images. A double-lumen silicone implant typically has an inner lumen of high-signal-intensity silicone surrounded by a smaller outer lumen that contains saline and has different signal intensities, depending on the pulse sequence (Fig. 5).

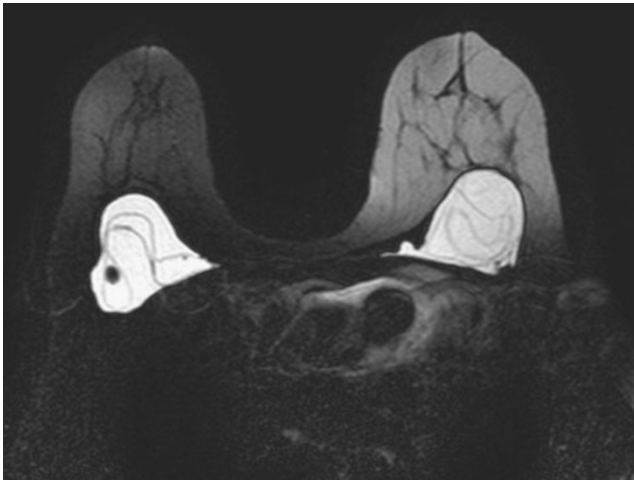
Fig. 6 Magnetic resonance imaging scan of a woman with bilateral ruptured implants. Typical “linguine sign” within implants representing collapsed implant shell

gel [5, 7, 9, 10, 12, 13, 16] (Fig. 6). The linguine sign will not be present in an uncollapsed rupture. In an uncollapsed

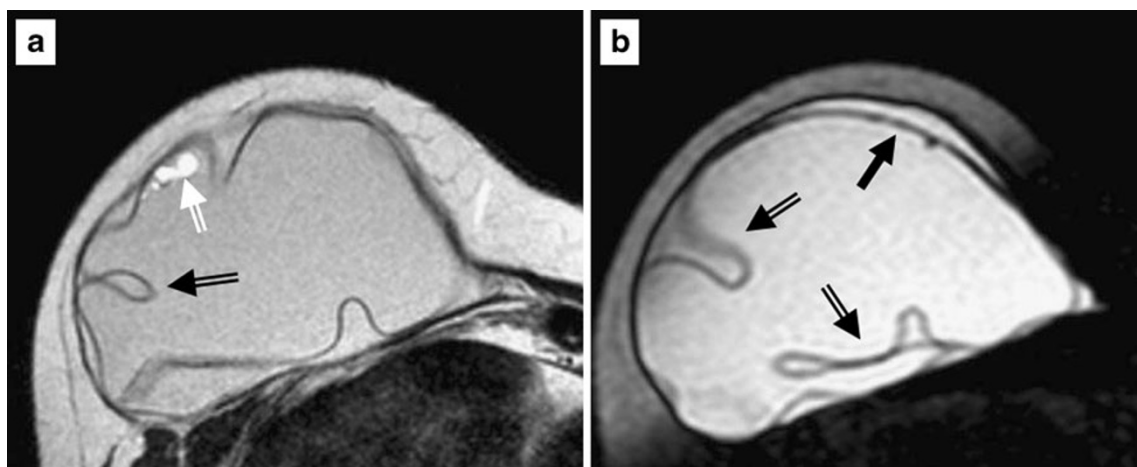
Fig. 7 MRI of a woman with intracapsular rupture of a single-lumen silicone implant. (a) Axial T2-weighted turbo spin-echo and (b) axial silicone-excited sequence. The study shows a hypointense subcapsular line at the anterior margin of the implant (solid arrow); the “teardrop

sign” and “key-hole sign” are also present (open arrows). Focal change in signal at the anterior margin of the implant (white open arrow) can also be observed

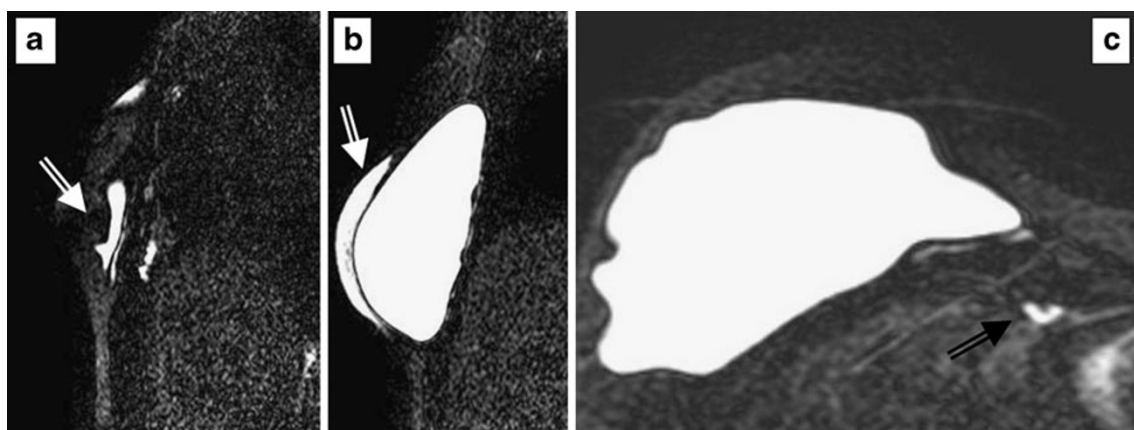
Fig. 8 MRI of a woman with an extracapsular rupture of a single-lumen silicone implant. **a** and **b** Sagittal silicone-excited sequences demonstrate the presence of free silicone gel around the implant (*white*

arrows). **(c)** Axial silicone-excited sequence shows free silicone gel located in the internal mammary chain (*black arrow*)

Extracapsular silicone implant rupture is defined as rupture of both the implant shell and the fibrous capsule, with macroscopic silicone leakage that extends beyond the fibrous capsule into surrounding tissues. Focal areas of high signal intensity in sequences that enhance only the silicone represent free silicone [5, 9, 12, 16] (Fig. 8). The linguine sign is often present with extracapsular ruptures.

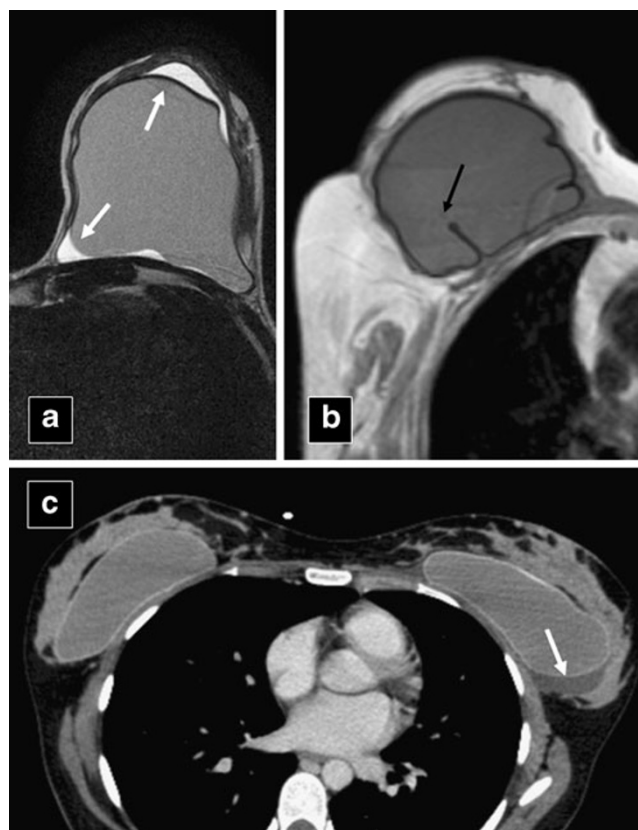
Fig. 9 Axial T2-weighted turbo spin-echo image (**a**) and axial CT scan (**c**) of single-lumen implants show small amount of reactive fluid (arrows). (**b**) Axial T1-weighted turbo spin-echo image demonstrates normal radial folds of the membrane (arrowhead). Simple or complex folds are not in themselves indicative of rupture

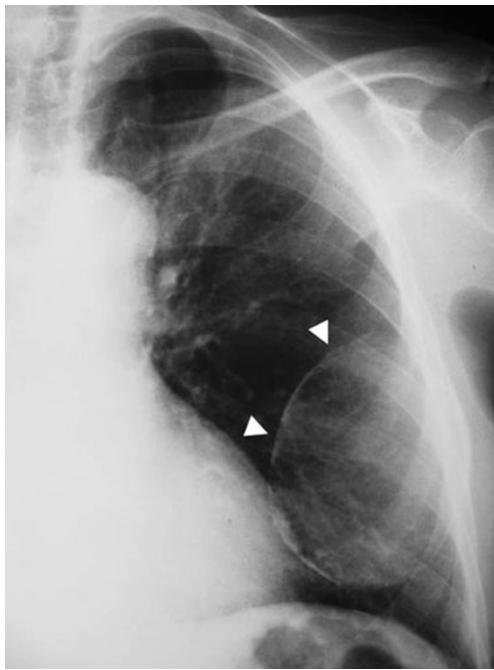
Fig. 10 Chest plain film of a woman with capsule calcification (*arrowheads*) adjacent to the implant. Many augmented patients develop capsular contracture

Radial folds are frequently observed in patients with capsular contracture. Capsular contracture is the most common complication. It is caused by excessive scar tissue around the implant that tightens and squeezes the implant. Occasionally, the capsule tears, allowing part of the implant to herniate into adjacent parenchyma. The capsule sometimes calcifies, and rigid calcium deposits may be palpated immediately adjacent to the implant (Fig. 10) [18].

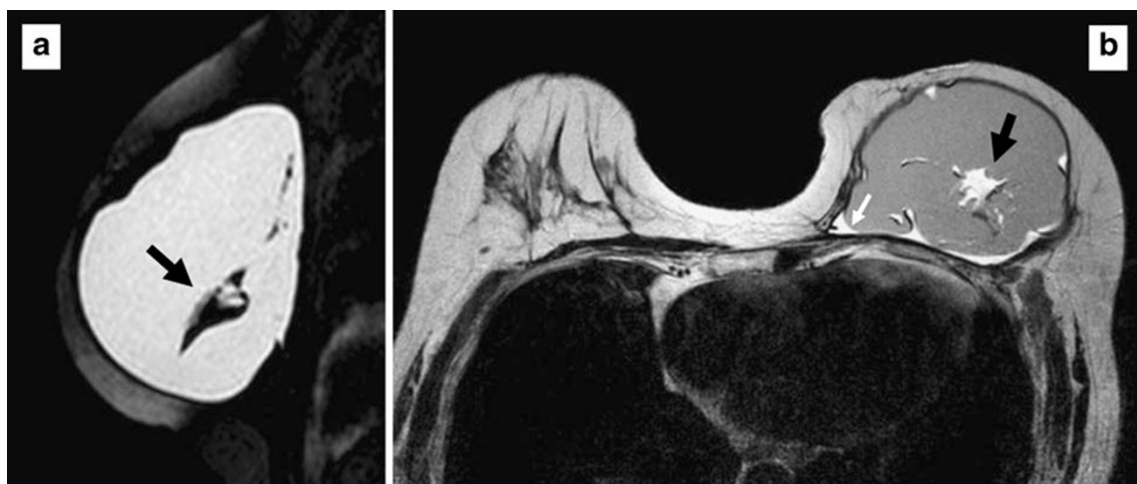
Fig. 11 **a** Sagittal silicone-excited MRI sequence and **(b)** axial T2-weighted turbo spin-echo image of a 64-year-old woman with changes in the signal intensity of the silicone gel (*black arrows*). The margins

of the implant are slightly irregular and a small amount of fluid surrounds the prosthesis (*white arrow*). A ruptured implant was confirmed at surgery.

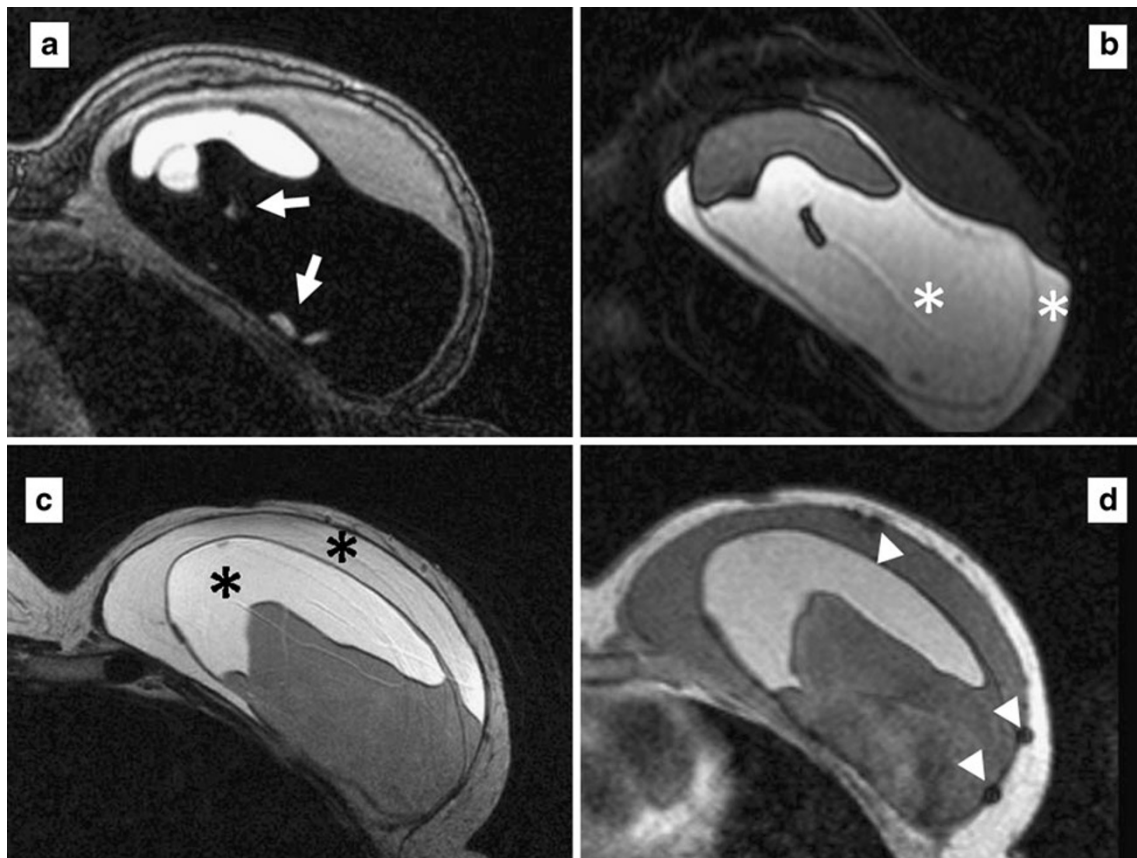
Fig. 12 MRI of a 54-year-old woman with a ruptured breast implant confirmed at surgery. **a** Axial silicone suppression. **b** Axial silicone-excited sequence. **c** Axial T2-weighted turbo spin echo. **d** Axial T1-weighted turbo spin echo. Silicone gel (white asterisks) inside and outside the implant. A moderate amount of water and probably serum

is mixed in the silicone gel around the implant (black asterisks). Note also the punctate changes in signal intensity—droplets within the implant (arrows) and punctate and hyperintense images due to calcifications in the implant periphery (arrowheads)

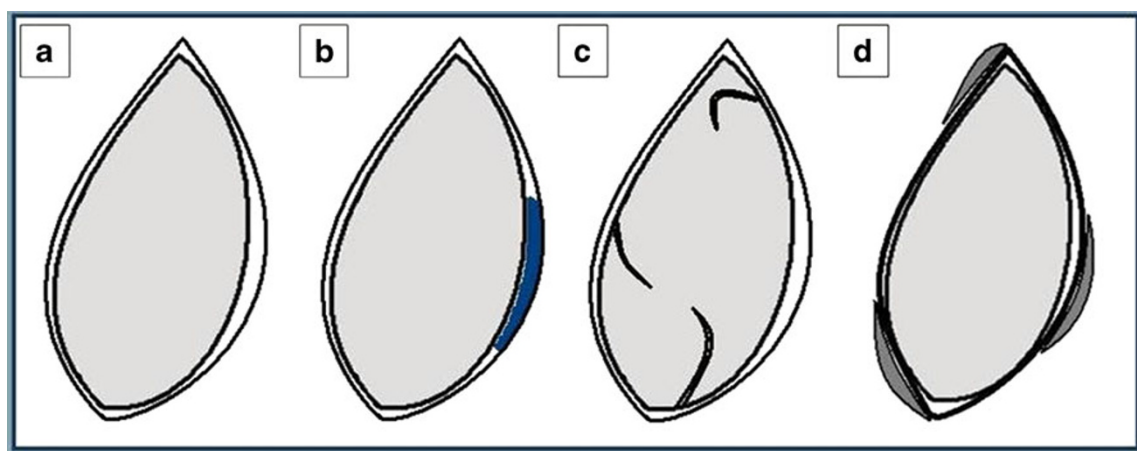
Fig. 13 Variants of normal breast implants. **a** Intact implant has an uninterrupted shell and fibrous capsule adjacent to the breast parenchyma. **b** Periprosthetic fluid. Presence of a small-to-moderate amount of reactive fluid surrounding the implant. **c** Simple or complex

radial folds. Lines extending from the surface of the implant and inwards in a rather perpendicular manner. **d** Calcification and thickening of the fibrous capsule

lumen; these findings are referred to as the “salad oil sign” or “droplet sign”. Without other MRI evidence of implant rupture, like the identification of the collapsed implant shell or free silicone within the breast parenchyma (with no previous history of implant rupture), water droplets or small amounts of air within a silicone implant are not reliable signs of implant rupture [9, 10, 16]. However, this sign should prompt the search for subtle signs of intracapsular rupture [16] (Figs. 11 and 12). The entire spectrum of MRI findings for silicone breast implants is illustrated in Figs. 13, 14 and 15.

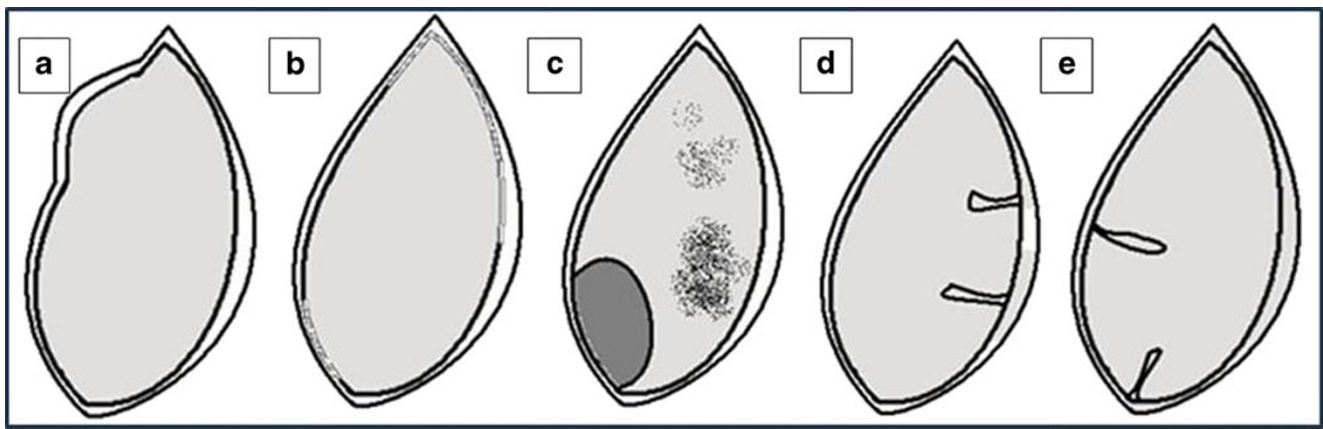
Fig. 14 Findings of possible breast implant rupture. **a** Deformity in contour. The border of the implant is bulging more than usual (called the “rat-tail sign” when very pronounced). Sometimes rupture cannot be differentiated from herniation. **b** Irregular margin. The border of the implant is blurry. Frequently seen with calcification of the fibrous capsule. **c** Changes in the signal intensity of the silicone gel. Water/

serum mixed in the silicone gel through a defect in membrane. **d** “Noose sign” or “key-hole sign”. Small invagination of the shell where the two membranes do not touch. **e** “Teardrop sign”. Invagination of the shell containing a droplet of silicone. The last two images represent silicone gel leakage through a small focal implant shell tear

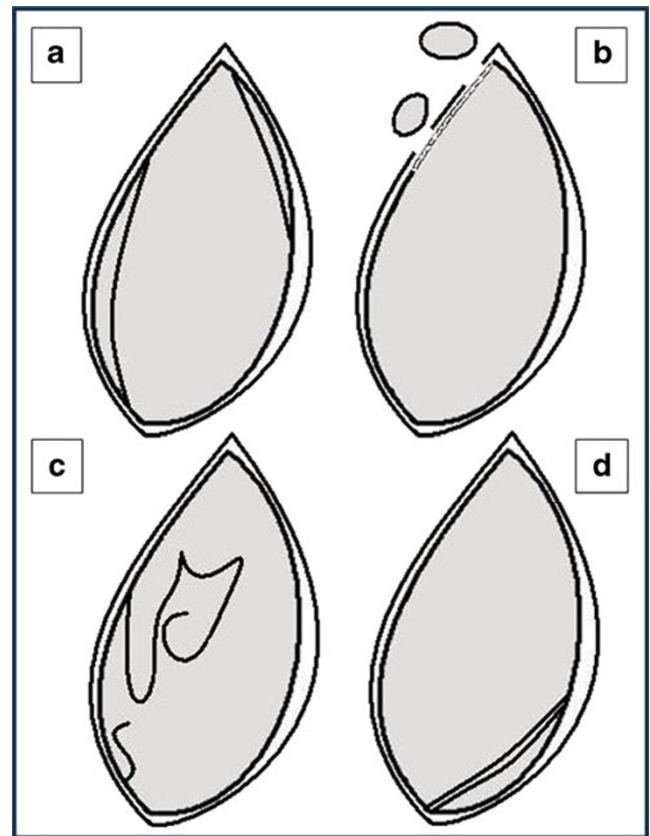
Fig. 15 Definitive findings of breast implant rupture. **a** Subcapsular lines. Lines running almost parallel to the fibrous capsule and just beneath it. The beginning and the end of the line can be followed to the surface of the implant. **b** Siliconomas and free silicone. Disruption of the shell and fibrous capsule will allow silicone to extravasate into surrounding breast tissue. **c** “Linguine sign”. Folded wavy multidirectional lines within the silicone gel, representing the collapsed implant shell. **d** “Railroad track sign”. Two parallel lines in close proximity forming a double-contoured subcapsular line within the silicone gel

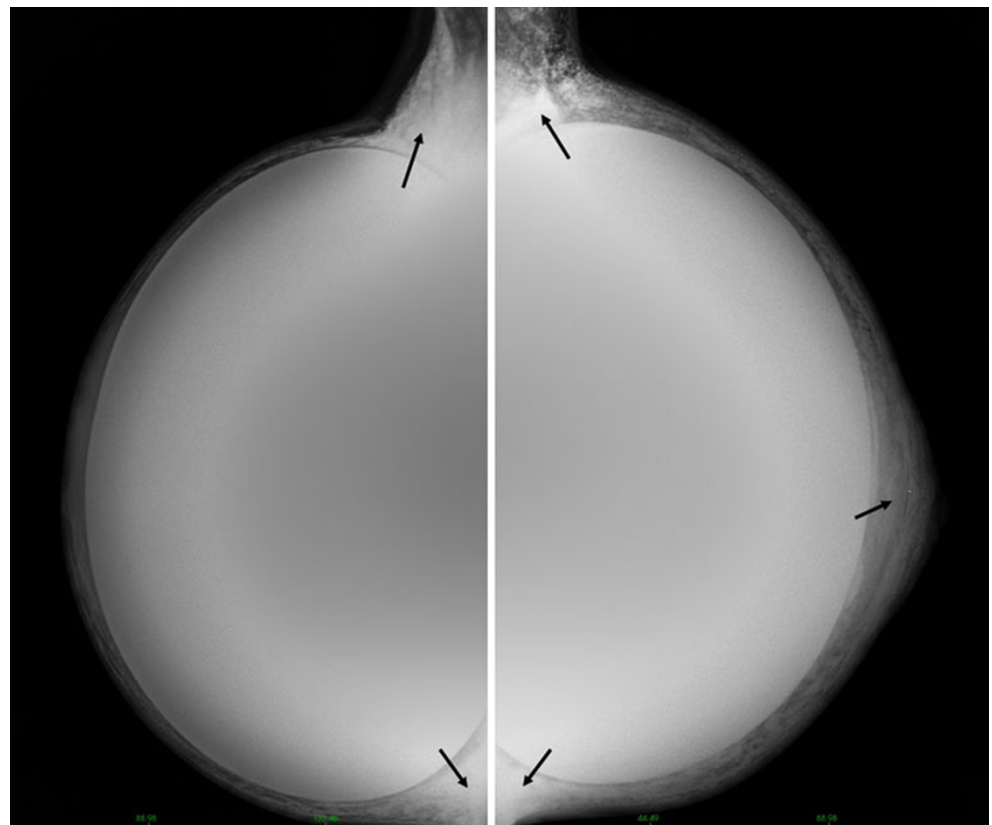
Fig. 16 Oblique mammograms in a 29-year-old transsexual with subglandular implants and silicone injections. Diffuse areas of increased density are visualised adjacent to the implant (*arrows*)

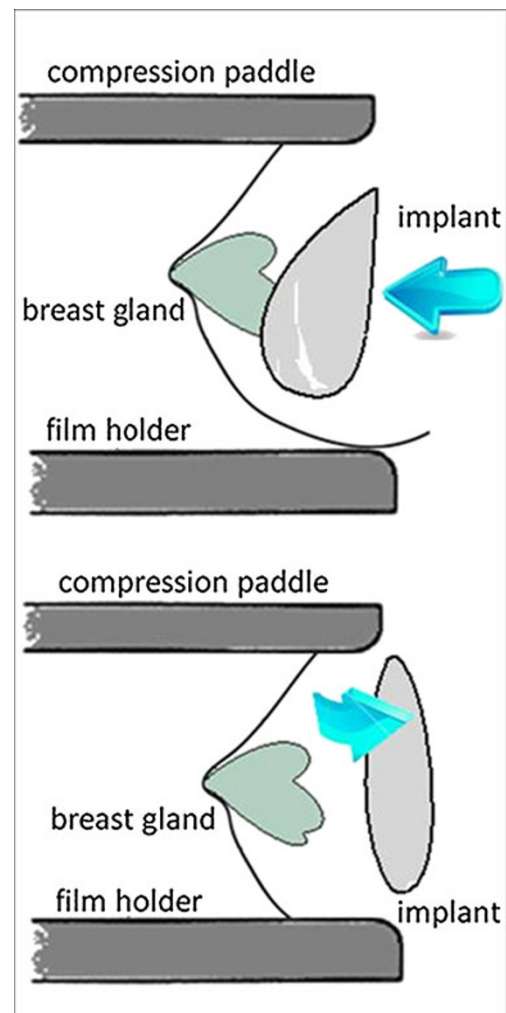
Fig. 17 Implant position is an important factor when studying the breasts. Patients with submammary implants have fewer visualised area compared to patients with submuscular implants. The displacement technique introduced by Eklund facilitates mammography in women with implants. Slightly more tissue is visualised with displacement (*below*) than with standard compression mammography (*above*)

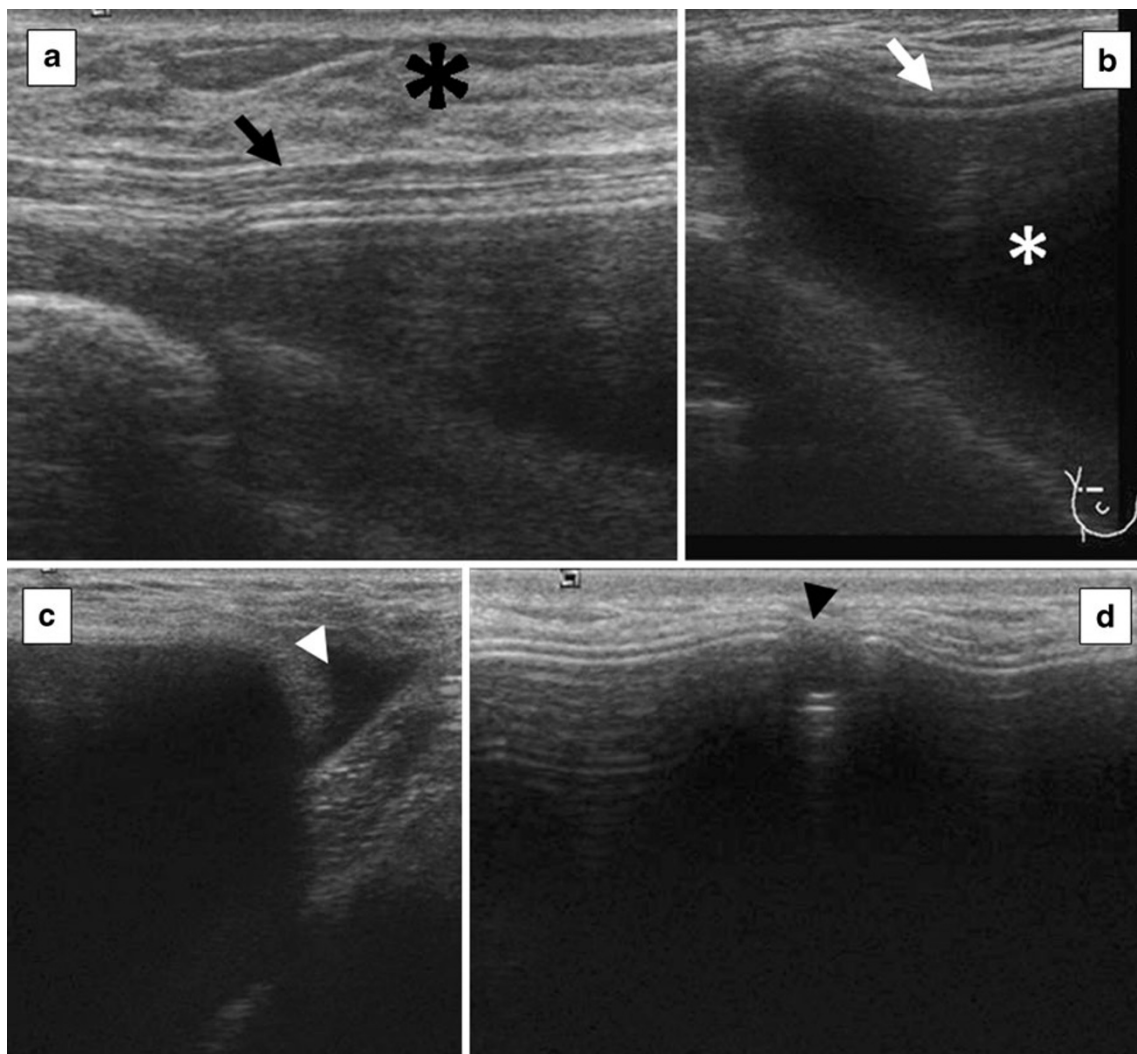
Fig. 18 **a** and **b** Ultrasonography of a woman with an intact implant. Breast gland (*black asterisk*), pectoralis major muscle (*black arrow*), and implant shell (*white arrow*) visualised as a thin and continuous echogenic line at the parenchymal tissue-implant interface, and

silicone implant (*white asterisk*). (**c**) A small fluid collection around the implant (*arrowhead*) and (**d**) a simple infolding of the shell silicone implant (*arrowhead*)

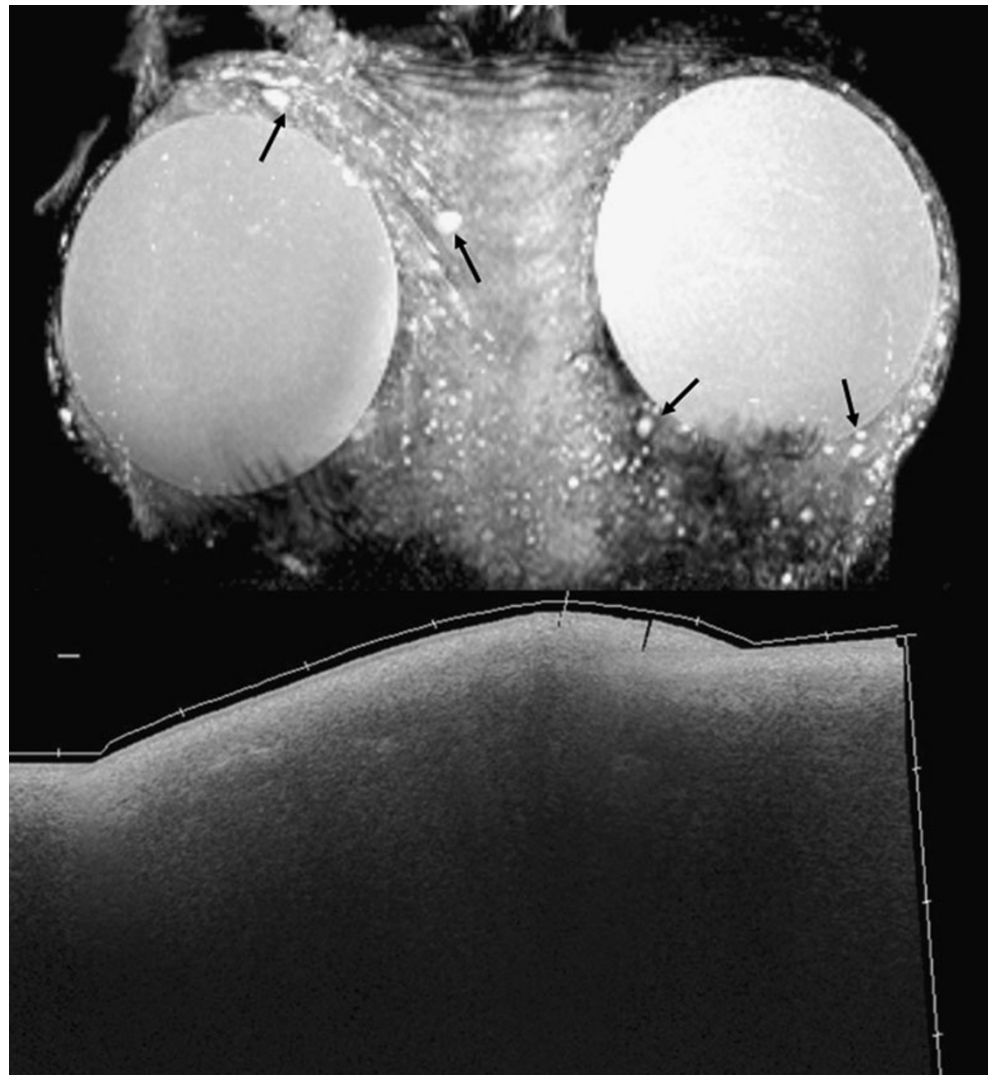
Fig. 19 (Above) A coronal maximum intensity projection from a silicone-excited sequence in a transsexual (Fig. 16) demonstrating multiple nodules with high signal throughout both breasts representing free silicone (arrows). (Below) It is extremely difficult to evaluate the silicone implants by ultrasonography because of attenuation of the ultrasound beam by the free injected silicone and granuloma formation in the subcutaneous tissue

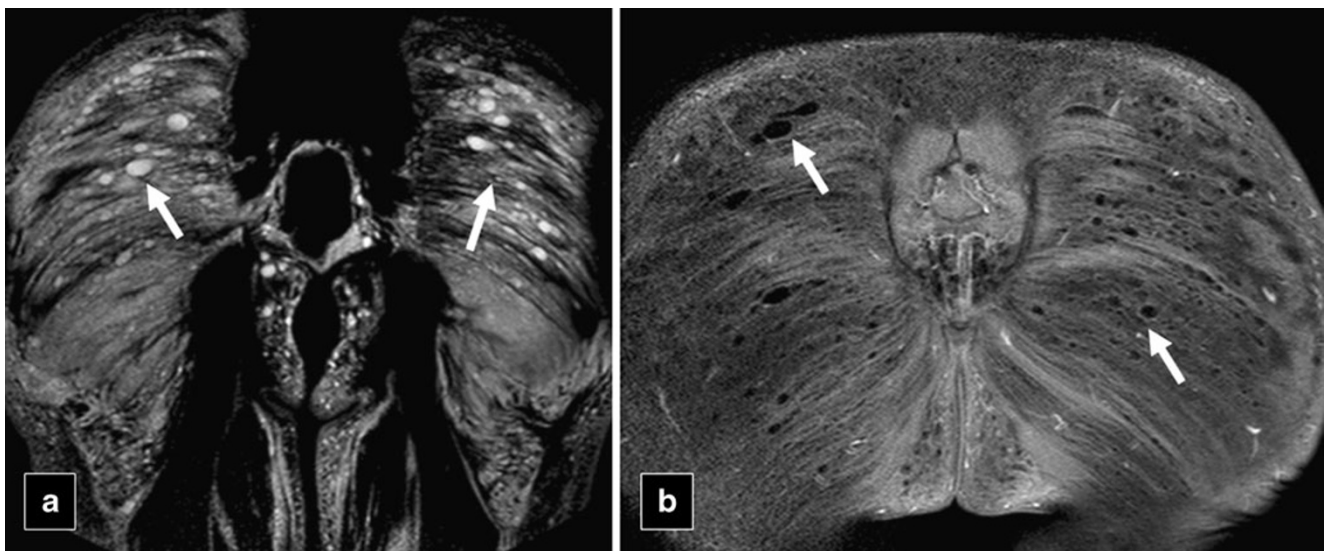
Fig. 20 **a** Coronal silicone-excited sequence and **(b)** coronal contrast-enhanced fat-suppressed T1-weighted image of the previous patient show multiple nodules of free silicone (“siliconomas”) in the gluteal muscles

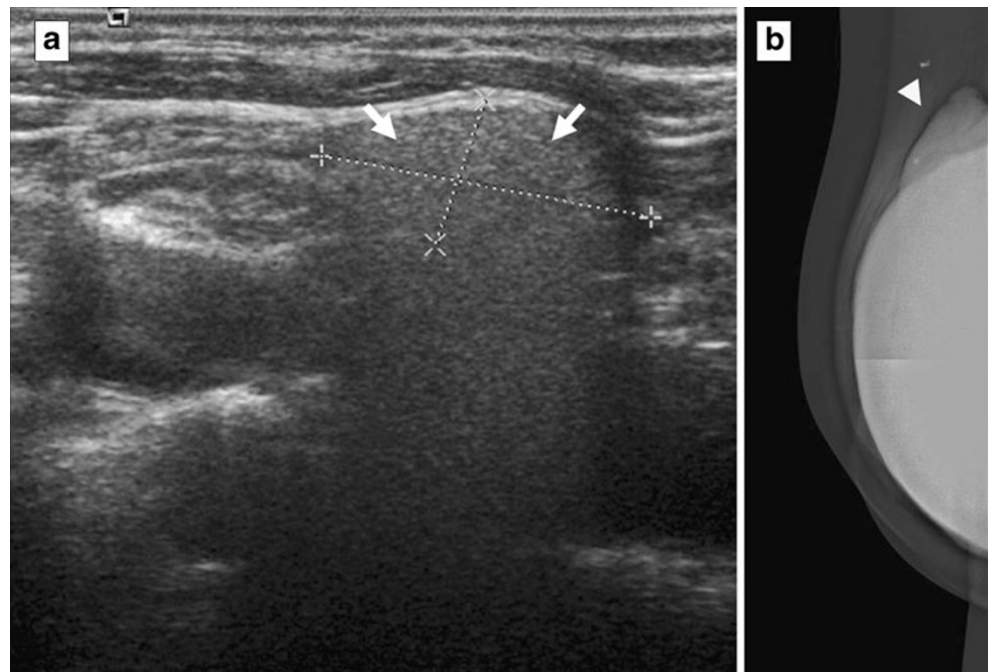
Fig. 21 Extracapsular silicone implant rupture in a 52-year-old woman with a history of breast cancer who presented with a palpable lesion in the supraclavicular right region. Mammogram shows an irregular lump from the implant (*arrowhead*) and ultrasonography demonstrates the presence of a nodular lesion with typical inhomogeneity (the “snowstorm sign”) at the posterior margin, suspicious for a lymph node containing silicone

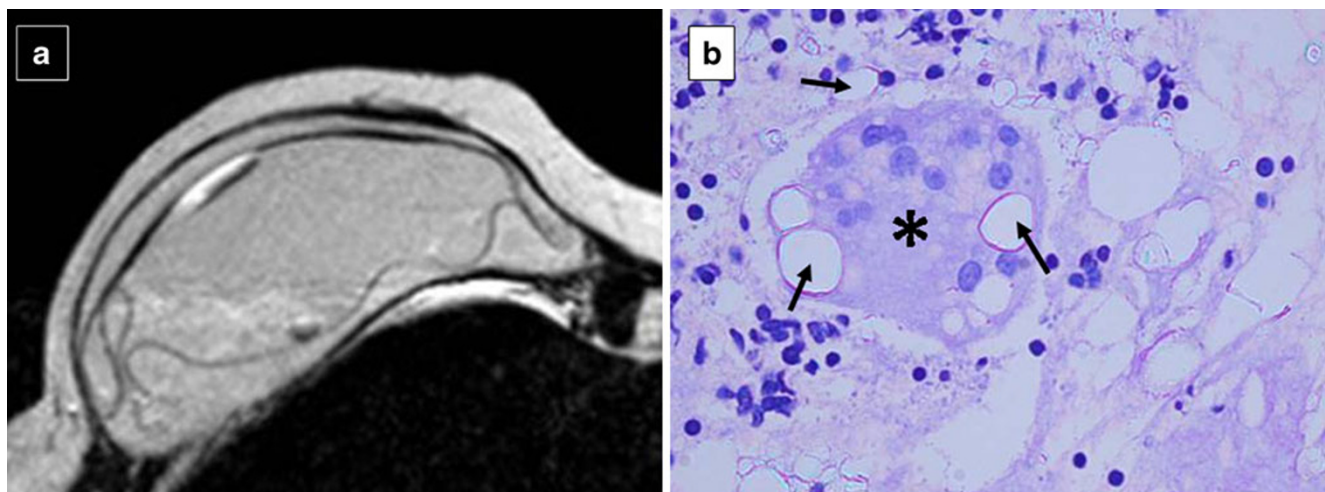
Fig. 22 Cytology of the node shows multinucleated foreign-body giant cells (*arrowhead*) with abundant birefringent particles inside and outside the cytoplasm, compatible with gel silicone (*arrows*). Axial

T2-weighted turbo spin-echo MRI study corroborated an extracapsular rupture of the implant

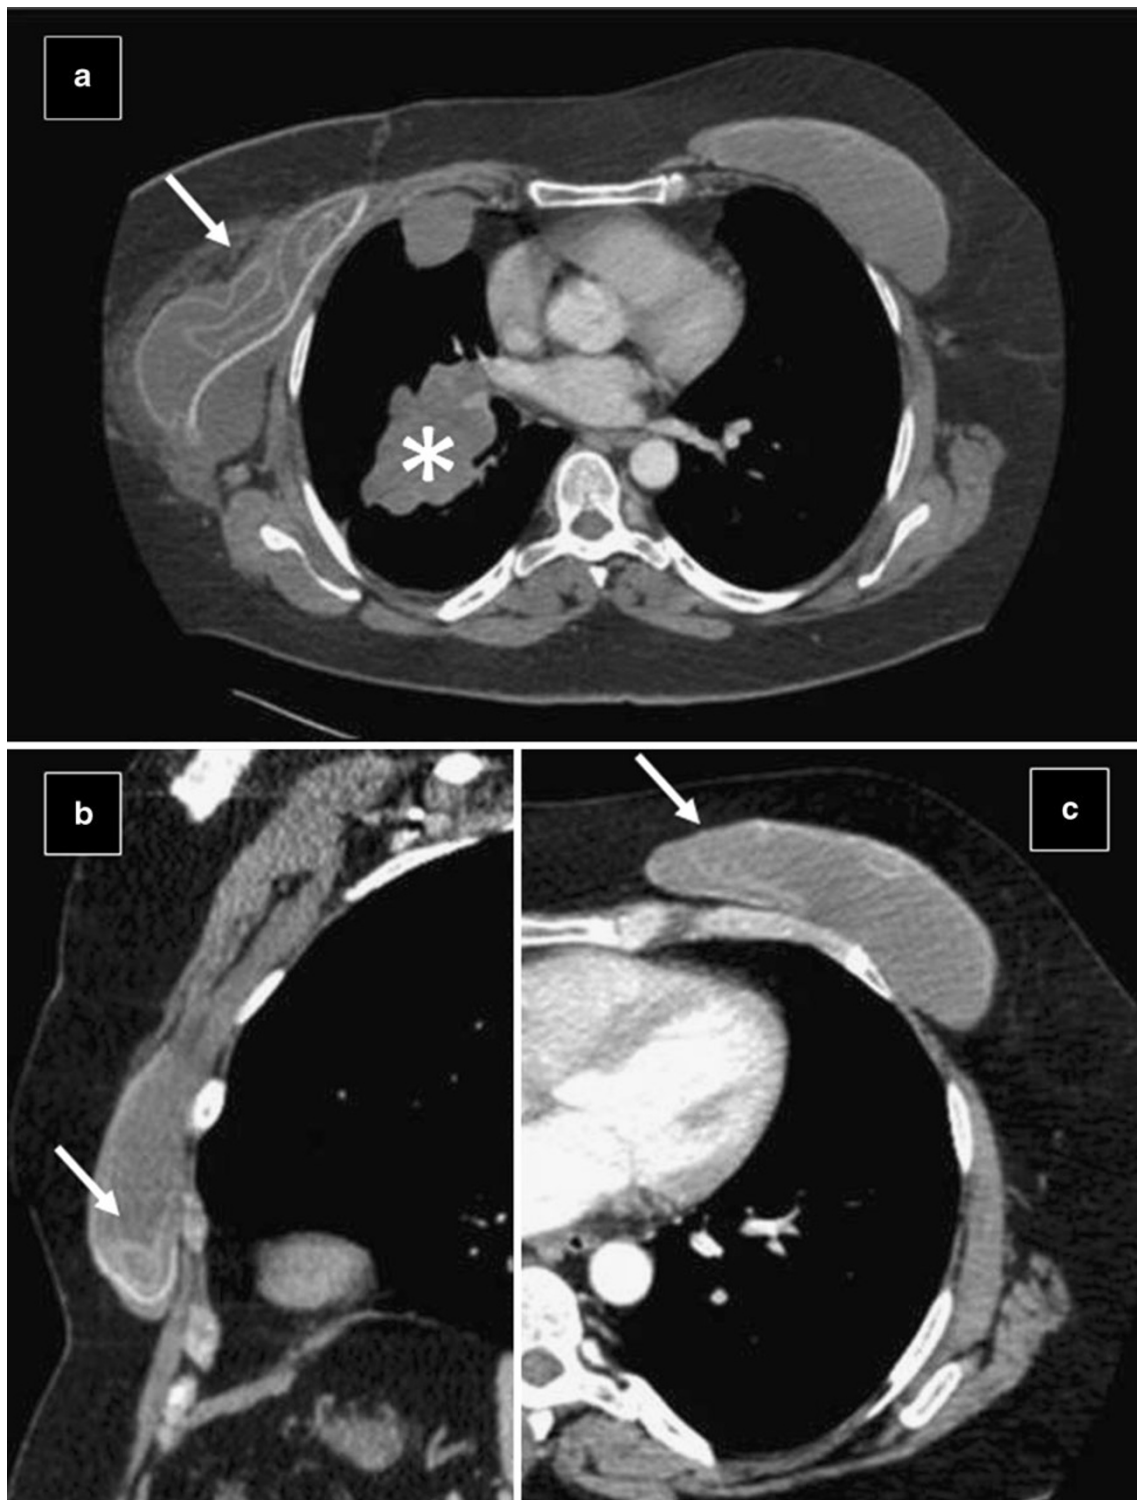
Fig. 23 Bilateral ruptured implants in a woman with primary lung cancer (*asterisk*). **a** Axial CT scan shows a severe deformity of the right implant surface representing a collapsed ruptured prosthesis

(*arrow*). **b** Sagittal multiplanar reconstruction and (**c**) axial CT scan of the left implant show high-density curvilinear lines within the implant ("linguine sign", *arrows*)

CT [8]. The collapsed implant shell can usually be easily identified (Figs. 23 and 24). Because silicone and soft tissues have similar radiodensities, extracapsular silicone can be difficult to identify on CT. However, in most cases of extracapsular silicone implant ruptures, CT can detect the collapsed implant shell, so the ruptured implant is not usually missed.

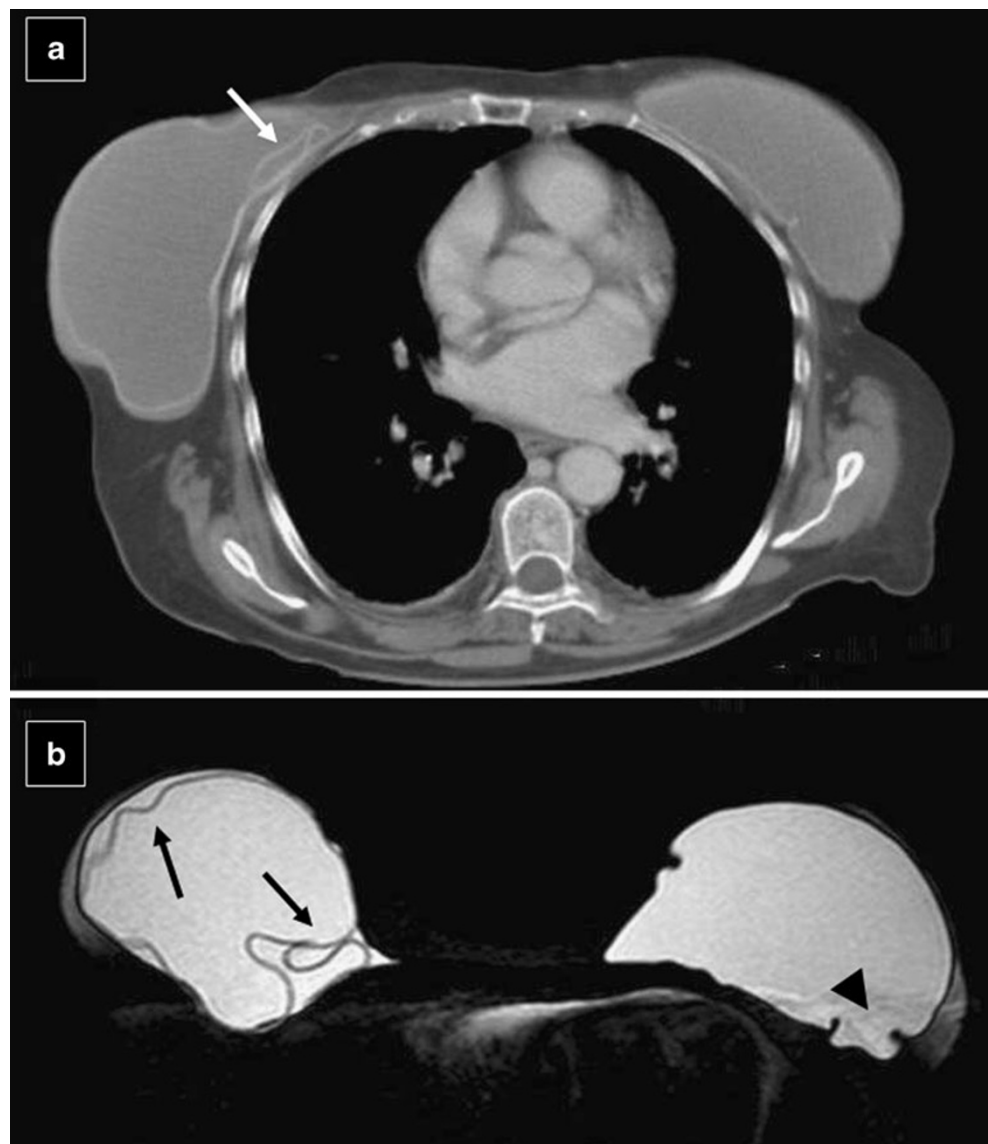
Fig. 24 Unilateral implant rupture. **(a)** Axial CT scan shows small high-density lines within the silicone gel in the right implant, suggestive of collapsed rupture (*arrow*). **(b)** Axial silicone-excited MRI sequence confirmed intracapsular rupture, showing hypointense wavy lines at the posterior margin of the right implant (“linguine sign”) and subcapsular line at the anterior margin (*arrows*). Normal infoldings in the left implant (*arrowhead*)

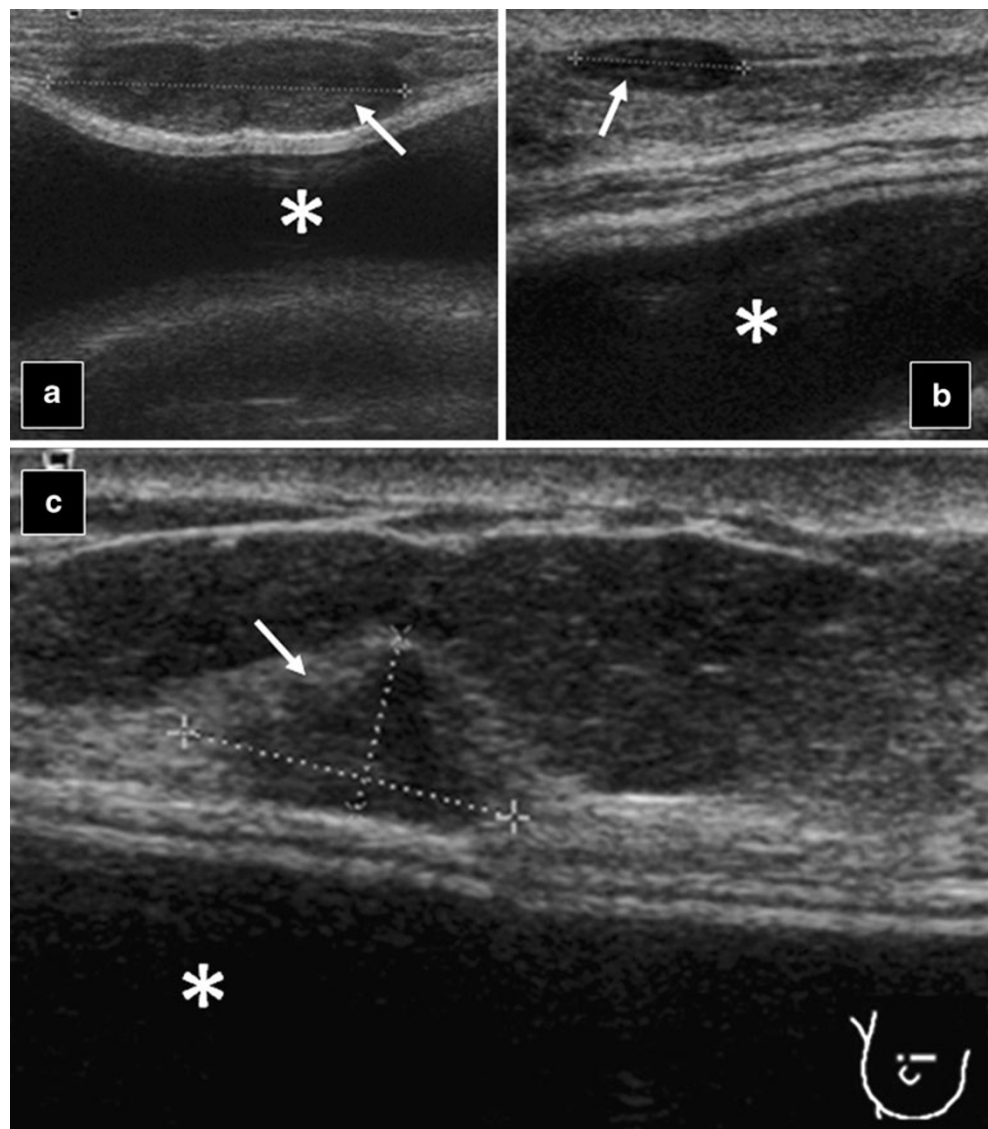
Fig. 25 Breast ultrasonography of a 39-year-old (**a**) and a 30-year-old (**b**) augmented women. In both studies there are two lesions (*arrows*) considered BIRADS III under follow-up. **c** Ultrasonography of a 46-year-old augmented woman with a history of breast cancer. US shows a lesion suspicious of recurrent tumor (*arrow*) that was confirmed by histology. Breast implant (*asterisk*)

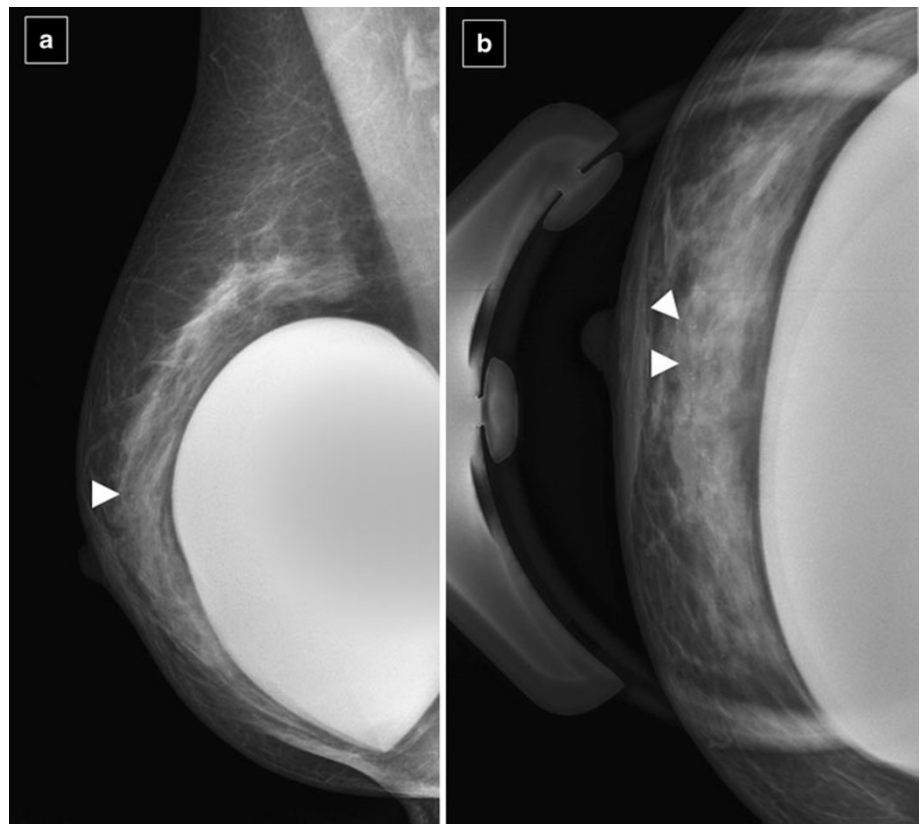
Fig. 26 An oblique mammogram of a 57-year-old woman with a submammary implant (a). A cluster of suspicious microcalcifications can be identified in the breast gland (arrows). A magnified mammogram (b) confirms the presence of malignant microcalcifications (arrows)

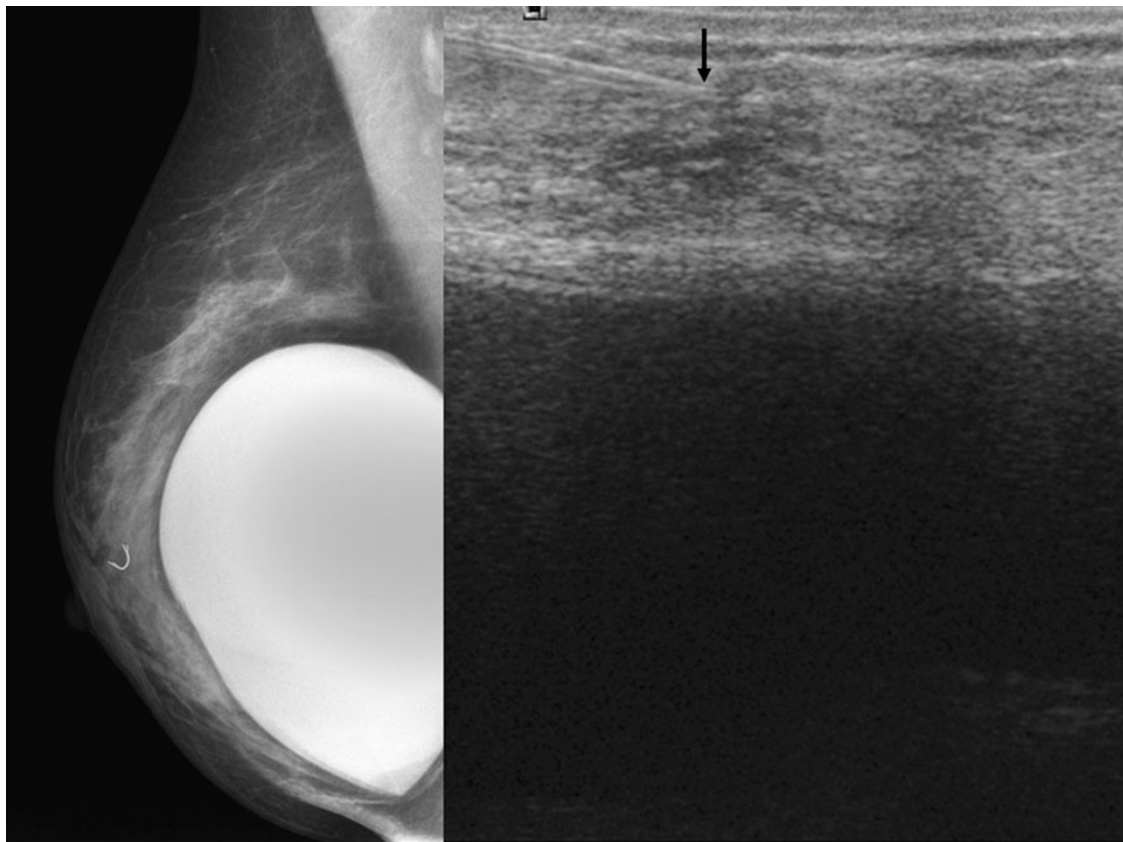
Fig. 27 (Left) Metallic clip placed in the microcalcifications site after biopsy. (Right) Real-time ultrasound is used to guide the needle tip (arrow)

MRI is clearly recommended in augmented woman with suspicion of a tumor [1]. All suspicious lesions should be analysed by fine-needle aspiration or core needle biopsy with maximum caution to avoid damaging the implant (Fig. 27).
